Re: Hurricane Damage Assessment Investigation  
Insured: Thomas & Pamela McIntosh  
Date of Loss: 8-29-2005  
SF Claim No. 24-Z178-602/24-BX-4847-7  
FAEC Case No: 530-0088-05-25

Title: Hurricane Damage Assessment Investigation  
Insured: Thomas & Pamela McIntosh  
Claim/Policy No.: 24-Z178-602/24-BX-4847-7  
FAEC File No.: 530-0066-05-25

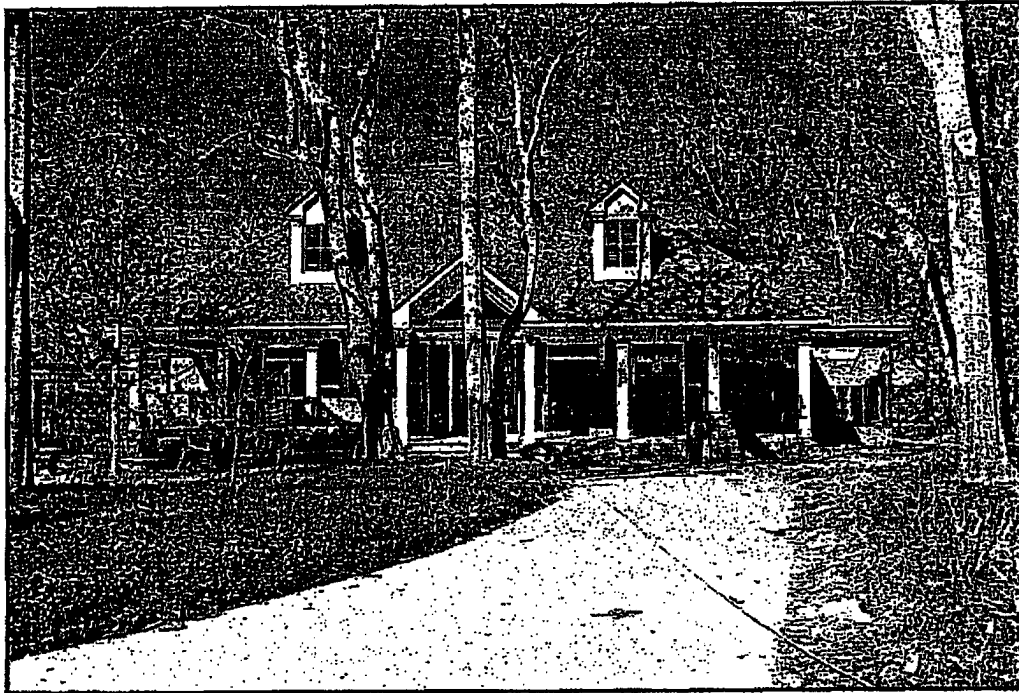
Photograph 1

- Photograph Number 1 - Front View of remains of residence located at 2558 S. Shore Dr., Biloxi, MS

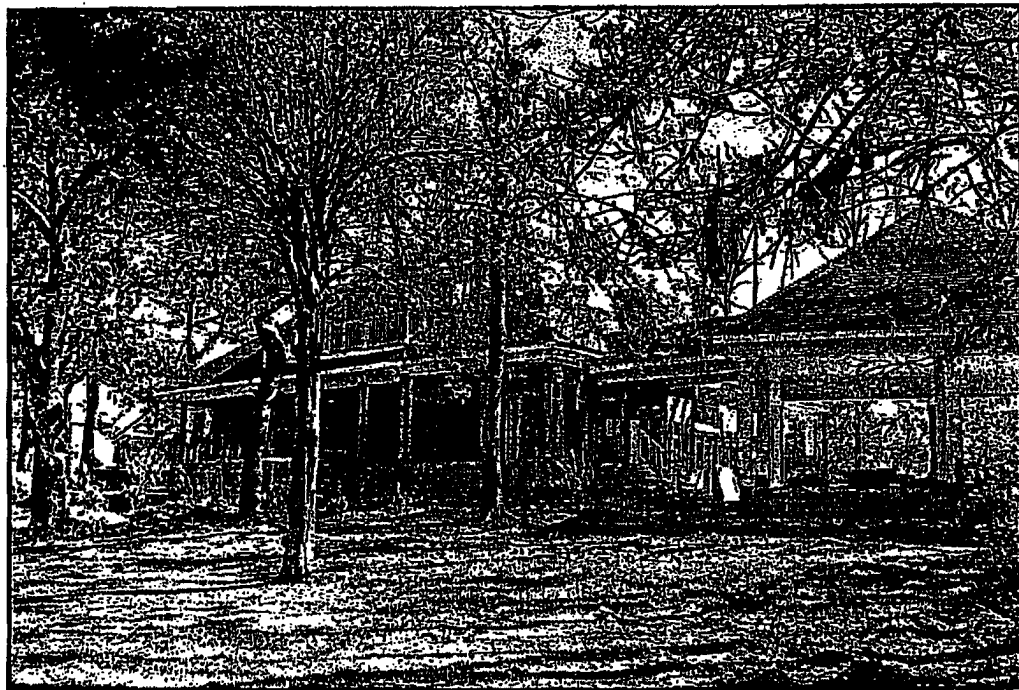
Photograph 2

- Photograph Number 2 - View of the rear of the house and carport

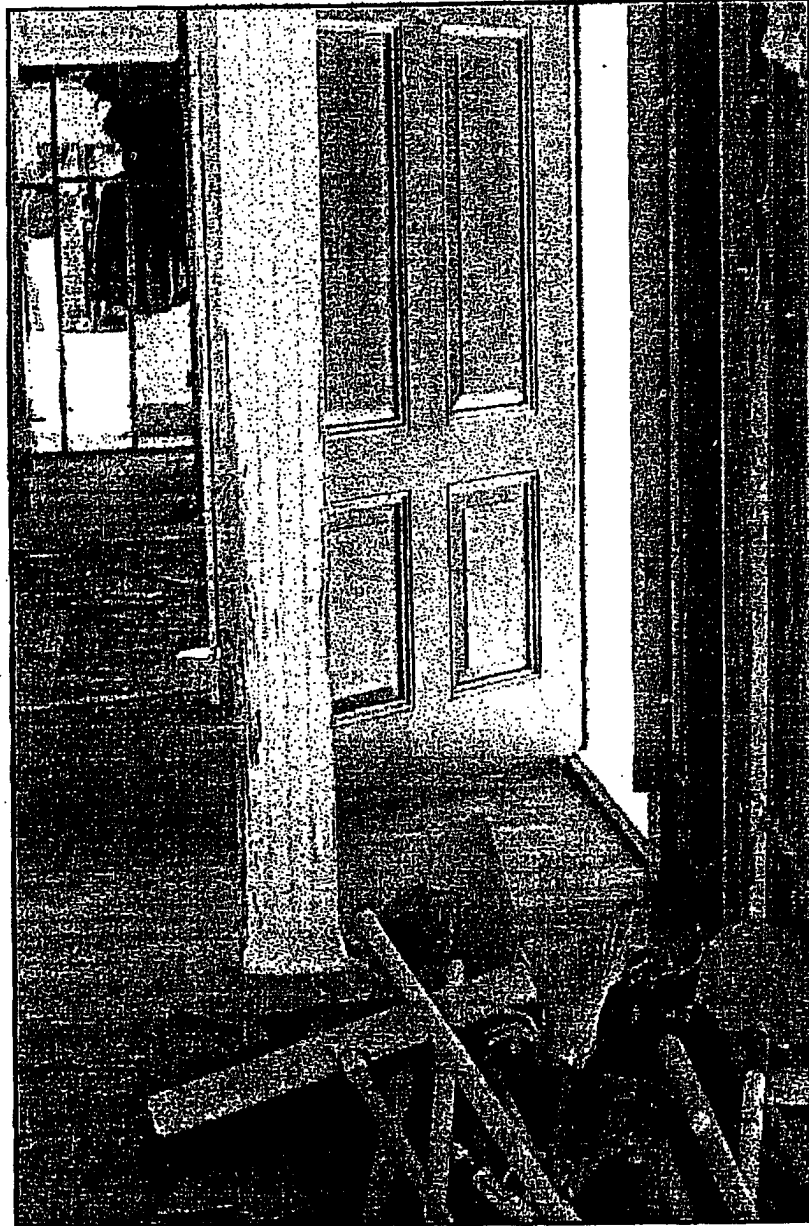
Photograph 3

- There were abrasion marks on a decorative column and the inside of French doors that lead from the dining room of the first floor out to the front porch. When Mr. Robertson was questioned on the cause of these, he was unsure, but stated that there was a brick wall on the south end of that room that had blown into the house and there was lumber in that room after the storm. He also commented that part of a neighbor's roof from across the cul-de-sac was in front of the carport, which was immediately south of the subject residence and outside of the mentioned brick wall. He mentioned that another part of that roof was in front of the north end of the porch. Observations of the exterior porch columns, which also show signs of abrasion for a distance of about 4 ft. above the porch floor. This again is consistent with part of a roof structure rubbing against the columns while being carried by water. At the point where it was said that the debris stopped (north end of porch) several trees showed abrasion marks similar to the porch columns.

- Photograph Number 3 - View of abrasion marks in dining room

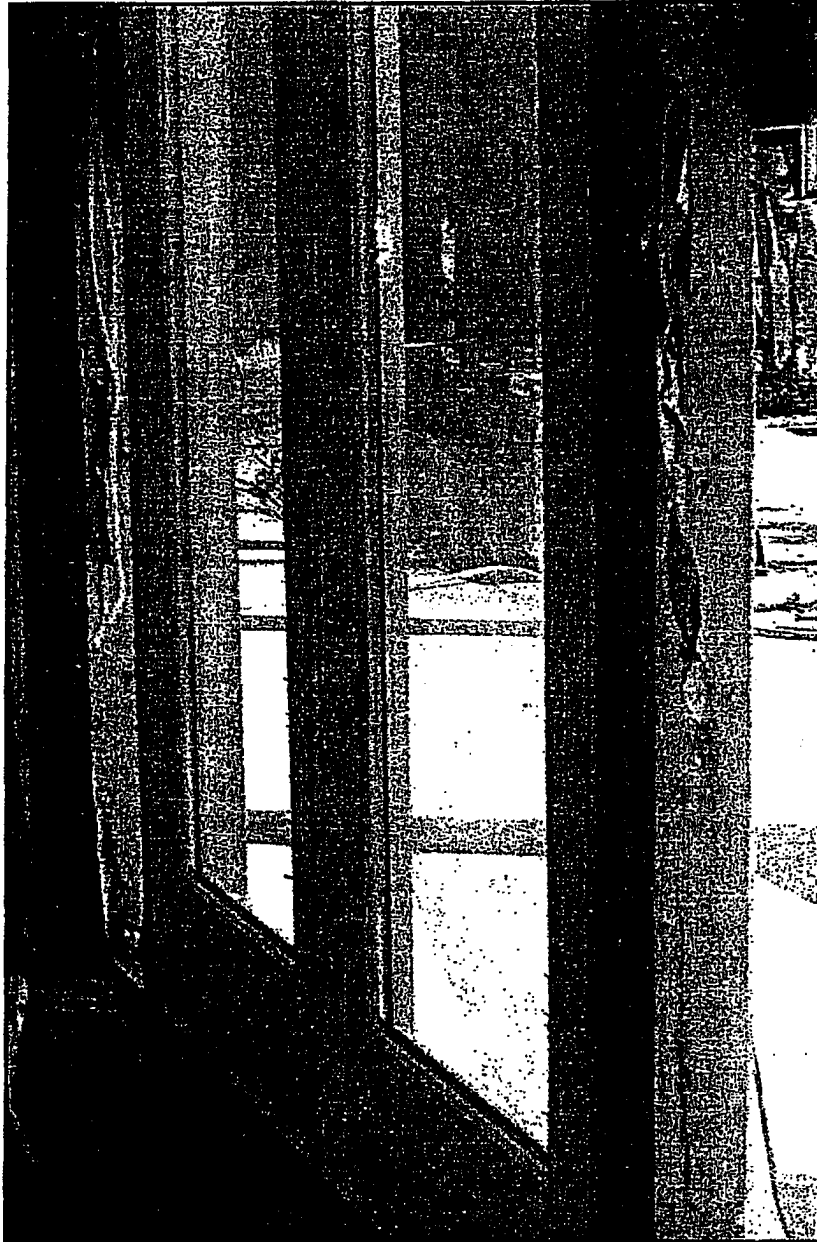
Photograph 4

- Photograph Number 4 - View of abrasion marks in dining room

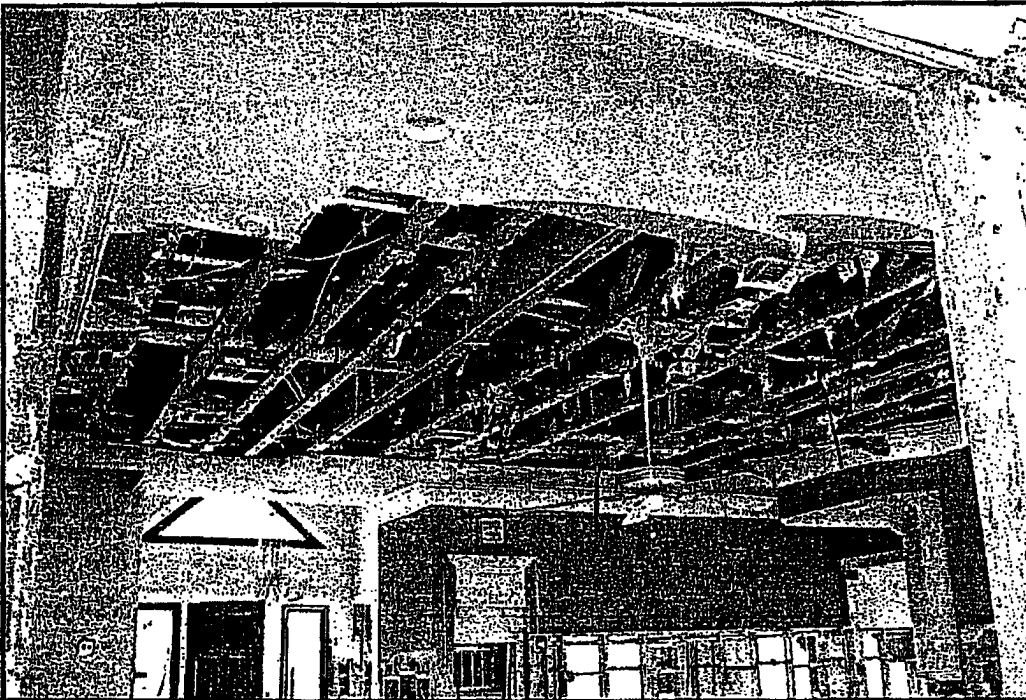
Photograph 6

- The tree failures in the northwesterly direction are the result of the winds out of the southeast from the approaching hurricane.
- There appears to have been damage to the structure by wind as evidenced by missing shingles on parts of the roof structure. Damage to the second story floor and first floor ceilings was predominately caused by wind and intruding rainwater.
- The damage to the first floor walls and floors appears to be predominately caused by rising water from the storm surge and waves.

- Photograph Number 6 - View ceiling damage on the first floor

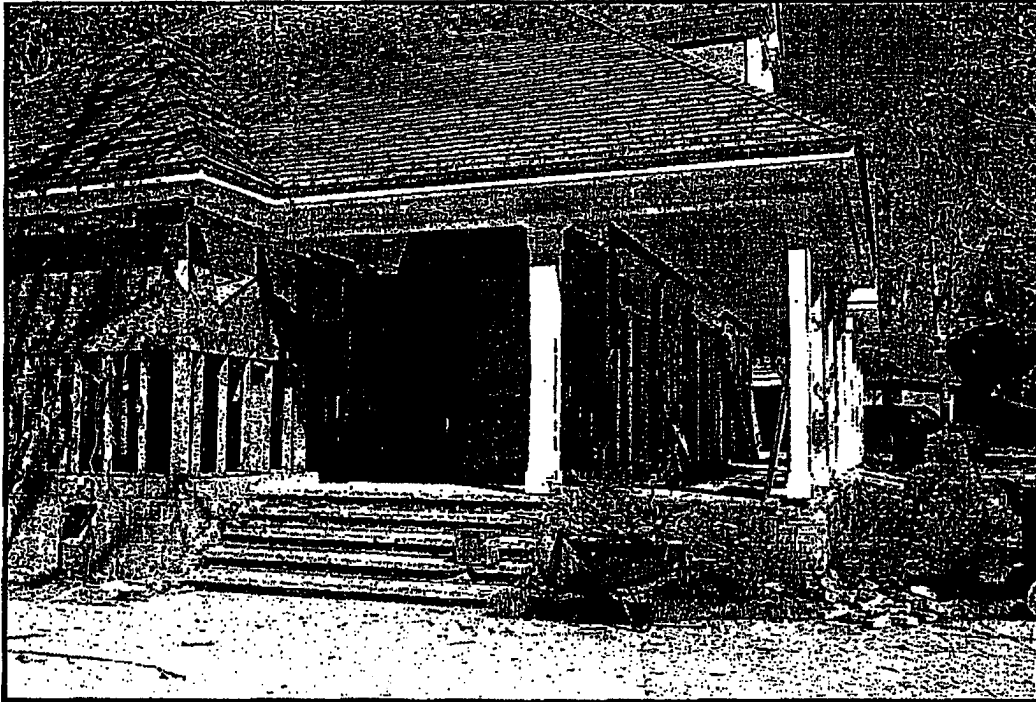
Photograph 7

House plans were not made available as to the construction of the left corner wall (entry from porch to the dining room). This corner has two walls. The east wall remains with French doors to the porch. The south wall was stated to be brick and it is unknown if doors were in that wall. The east doors would receive some protection from floating debris by the porch columns. It is understood that some lumber came in through the south wall into the dining room and that the bricks had fallen into the room. It is the opinion of FAEC that the damage to this wall was predominately due to waterborne debris hitting the wall.

- Photograph Number 7 - View of damage to front corner of residence

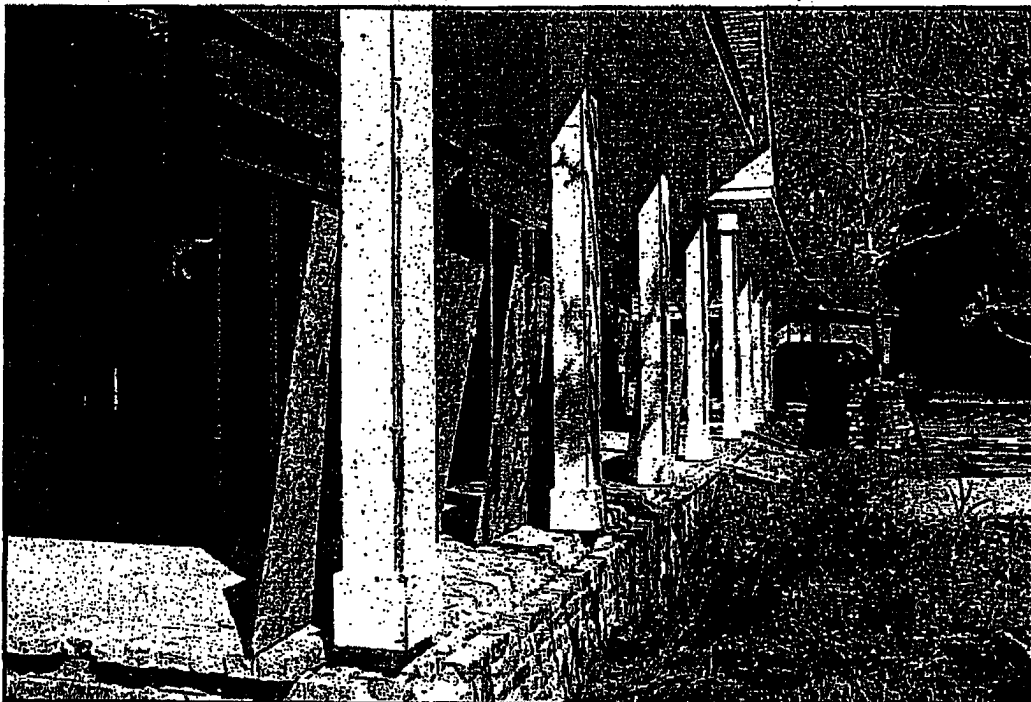
Photograph 8

- Photograph Number 8 - View of abrasions to front porch columns

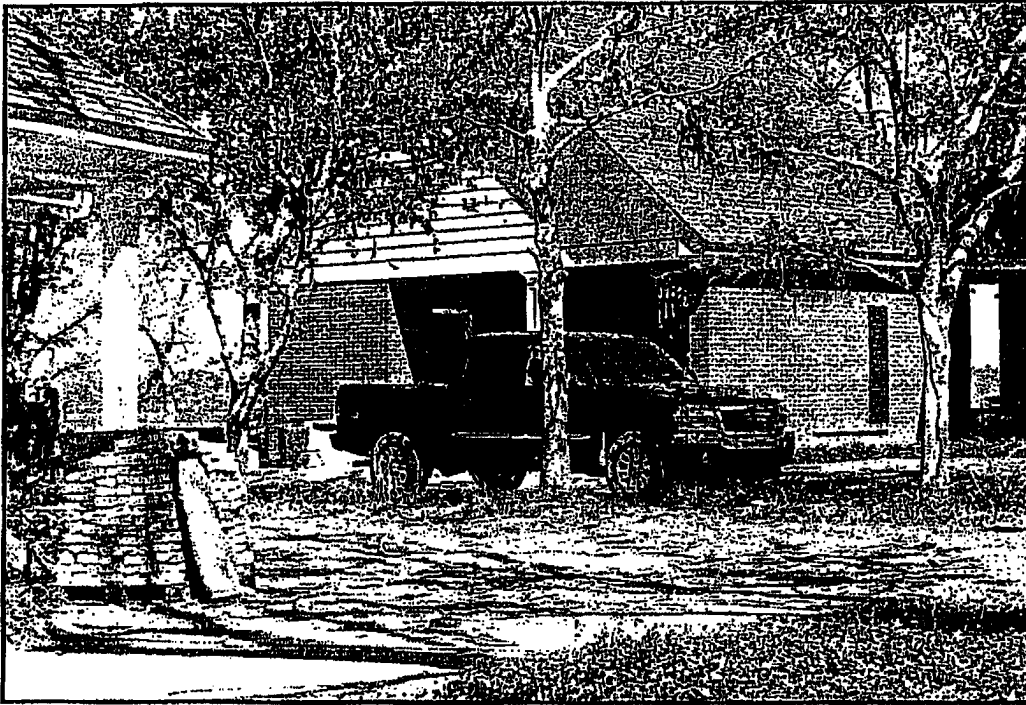
Photograph 8

- Photograph Number 9 - View of abrasions on trees at the north end of the porch
