**STATE FARM FIRE AND CASUALTY COMPANY'S MOTION
IN LIMINE NO. 9: TO PRECLUDE TESTIMONY OR EVIDENCE THAT
PLAINTIFF'S HOME WAS COMPLETELY DESTROYED BY WIND**

BUILDING DAMAGE ASSESSMENT

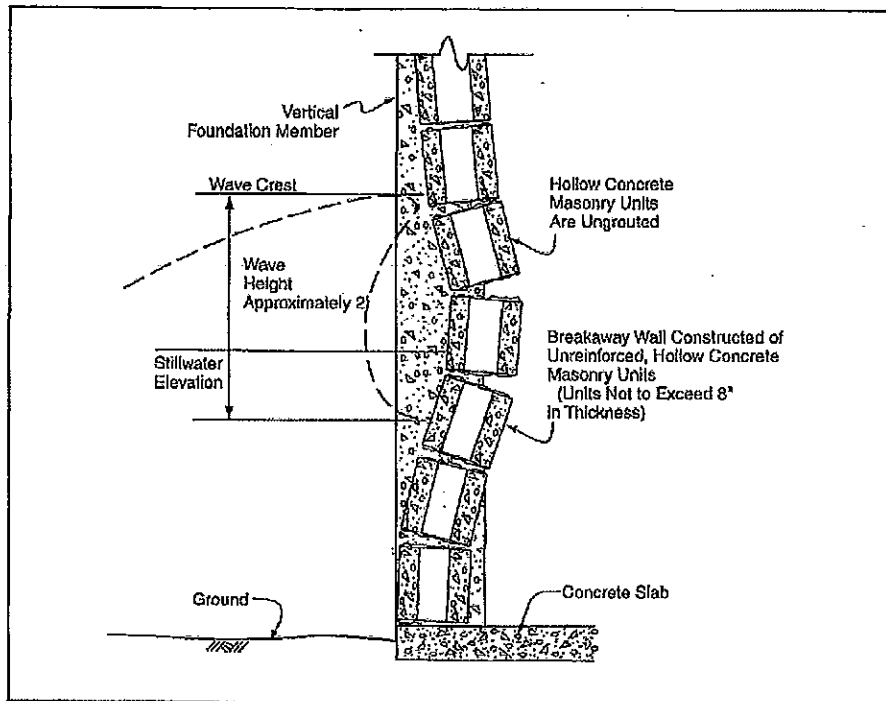
“Expected failure mode” of unreinforced masonry breakaway wall (FEMA 55)

9) Dr. Kriebel argues that the sun room brick fell outward to the southeast “counter to the wind direction”. Anticipating the question “didn’t they also fall counter to the direction of surge?”, Dr. Kriebel argues that because “waves are cyclic and oscillatory”, they load a wall...in both the direction of wave advance and in the opposite direction”. The argument is flawed. Why didn’t this mode of failure occur at the den where even the fireplace collapsed in the direction of wind? If wave action collapsed the wall (there is reason to believe it did not) then why didn’t at least the lower portion of the brickwork collapse inward as suggested by FEMA 55 Coastal Construction Manual (see figure below). Unless Dr. Kriebel is arguing that after impacting the wall, receding waves created a negative pressure coefficient which sucked the brick outward (an argument however which can be made for wind), his argument only is valid if waves attacked the wall from both sides. There is no compelling reason to believe that waves attacking the sun room wall could have collapsed all the brick outward as seen in photographic evidence.

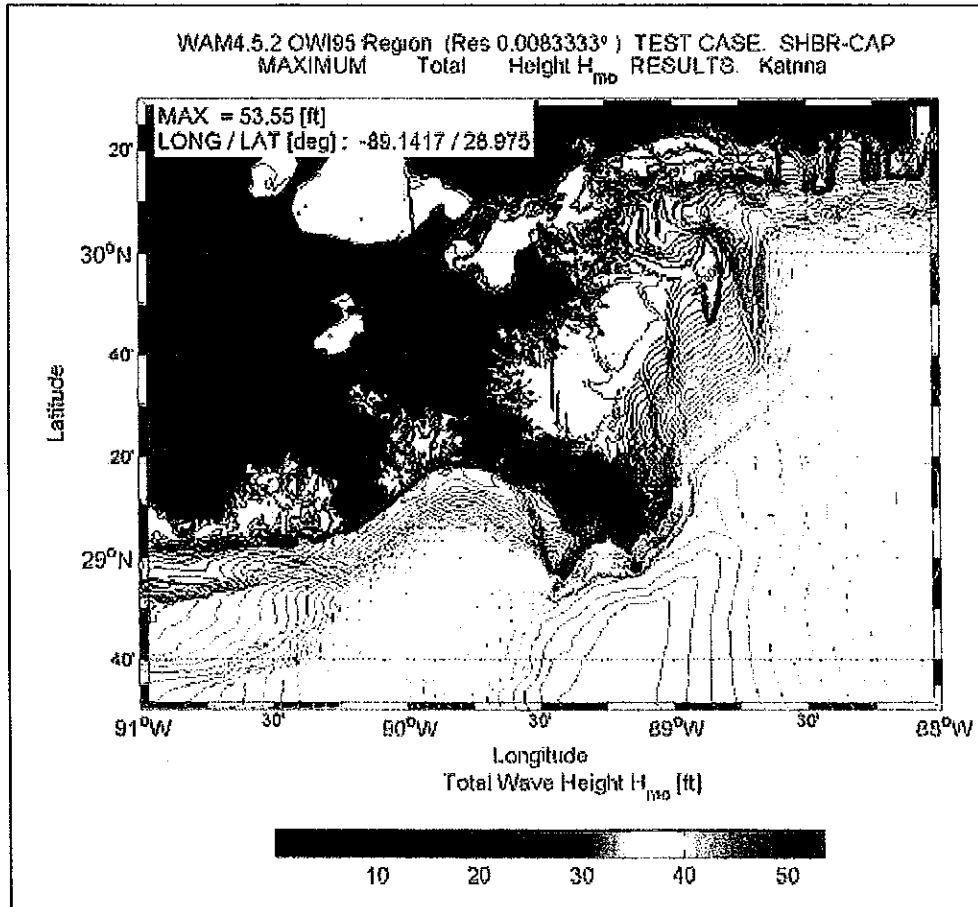
Figure 38. Color contour of the maximum wave height conditions in the region domain.

19) Dr. Kriebel notes that “there are no direction measurements of waves acting near the Payment home during Hurricane Katrina. The IPET report predicted wave fields for the Mississippi Sound and St Louis Bay, but these do not extend to the bayous or tidal tributaries. As a result, there are no published estimates of wave heights for a setting like that at the Payment residence” (page 29). To the contrary, the IPET report does display wave field data for the bayous. However, the scale and color resolution on the IPET report (Vol IV, Figure 38) makes it difficult to grab information concerning St Louis Bay and its bayous.

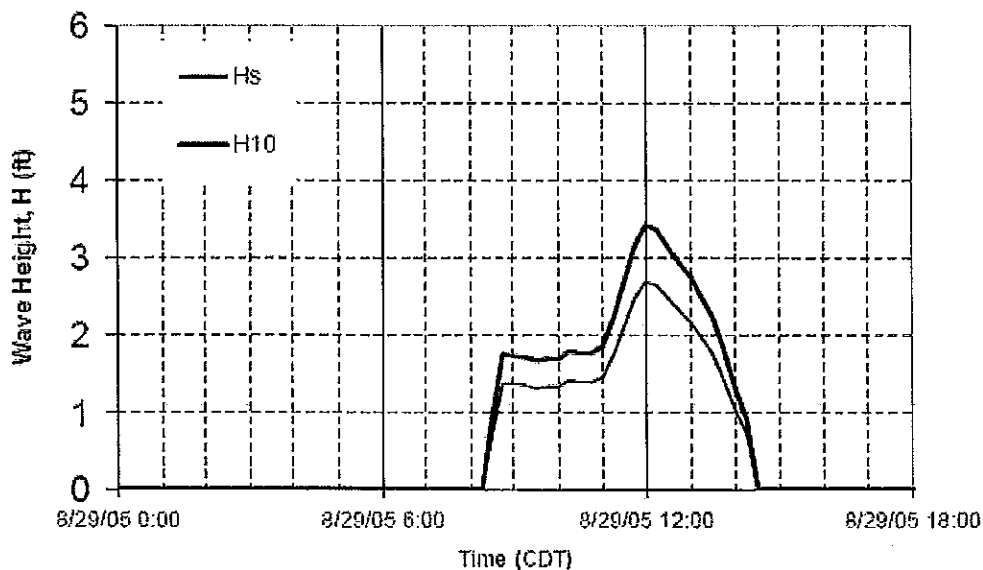
Figure 30. Predicted wave heights at Payment residence

20) Figure 30 in the Kriebel report (below) shows a detailed prediction of wave height over time. The source of this data is unclear. Similar presentations of wave height appear in reports authored by Dr. Kriebel for the Jourdan River Estates on the south shore of St Louis Bay, in which case Dr. Kriebel relied on ADCIRC and SWAN models provided by Dr. Don Slinn from the University of Florida. For example, his analysis for the Tully Residence at 105 Edith

Drive, Bay St Louis, MS (dated September 14, 2007) states that “Detailed estimates of wind speeds, water levels, and wave conditions at the Farrell site have been provided by Professor Don Slinn from the University of Florida. Professor Slinn uses the same wind fields used in the IPET study, applies the same storm surge model used in the IPET study (ADCIRC), and applies a refined shallow water wave model (SWAN) which is similar to the models used in the IPET study. Professor Slinn provides wind speeds, water levels, and wave conditions at 15 minute intervals, in contrast to coarser the 3-hour intervals for IPET winds and 1-hour interval for IPET storm tides.” It is unclear if Slinn’s model contains information useful to the analysis of the Payment residence and if so, if this information was used by Dr. Kriebel.
