## BUILDING DAMAGE ASSESSMENT

**ANTHONY RESIDENCE  
506 RIVERVIEW ROAD  
BAY ST. LOUIS, MISSISSIPPI 39520**

**AUGUST 29, 2005  
(HURRICANE KATRINA)**

**REPORT NUMBER 90000**

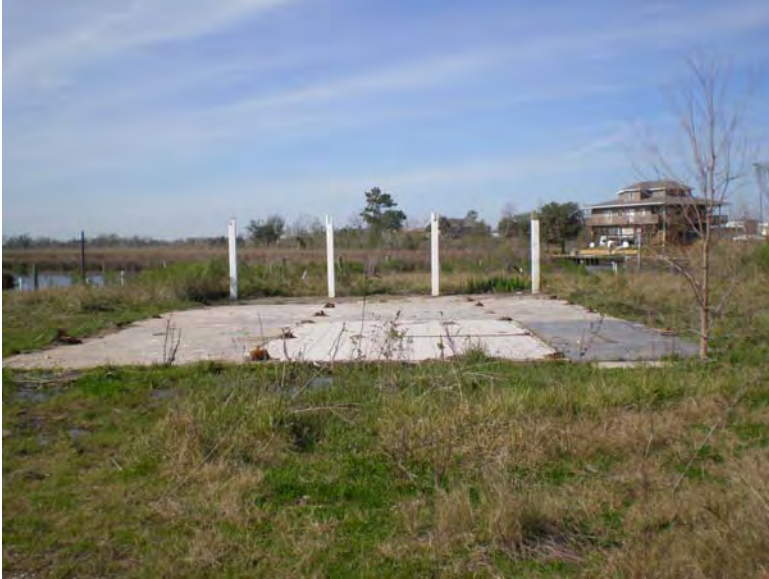
**Photo 1: Looking NW towards rear of building footprint**

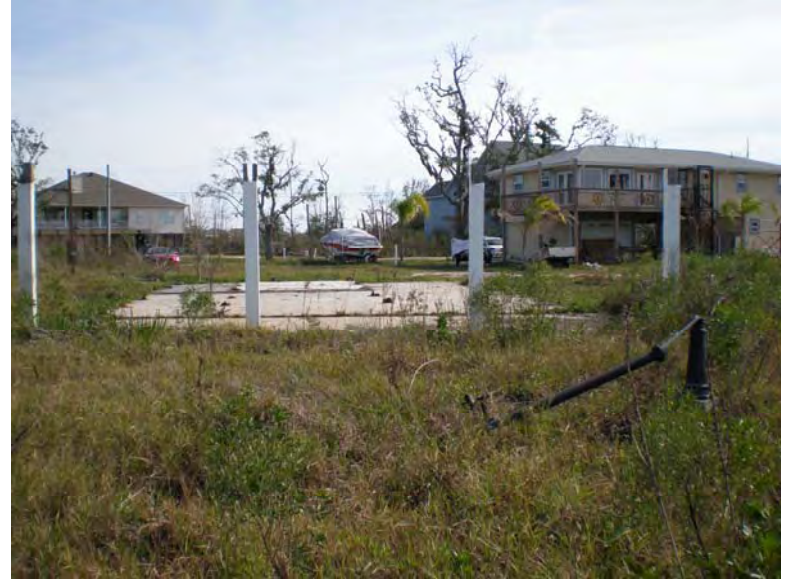
**Photo 3: Looking SE towards street**

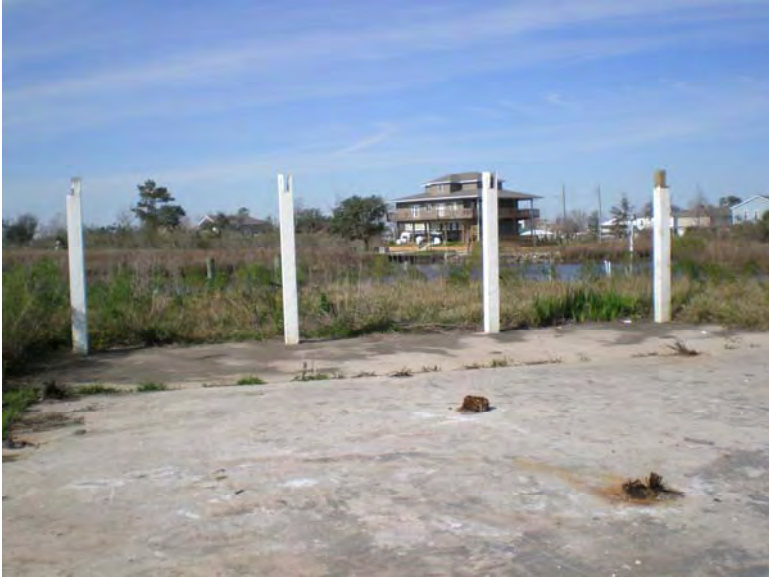
**Photo 2: Looking NW towards rear of building footprint**

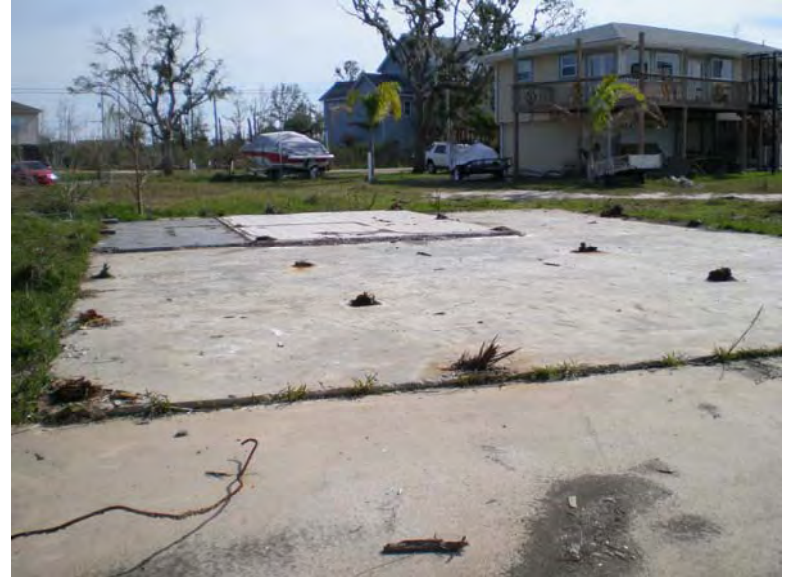
**Photo 4: Looking SE towards street**

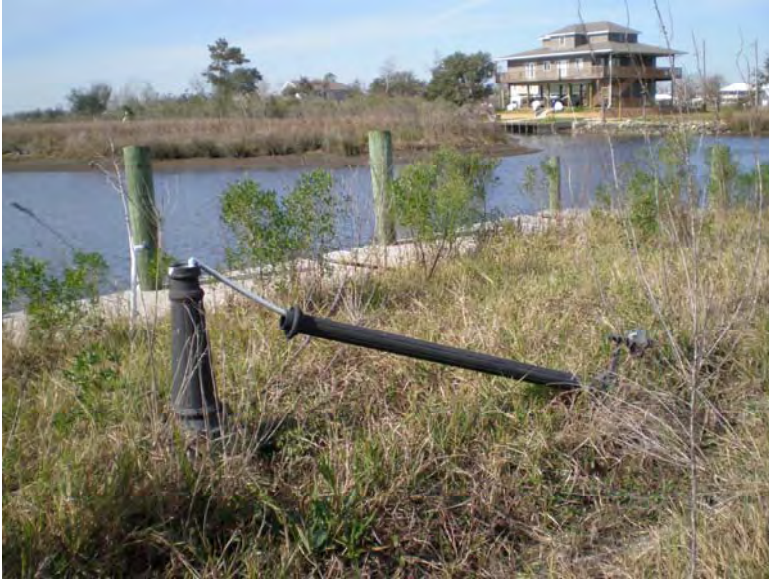
**Photo 5: Snapped lightpole**

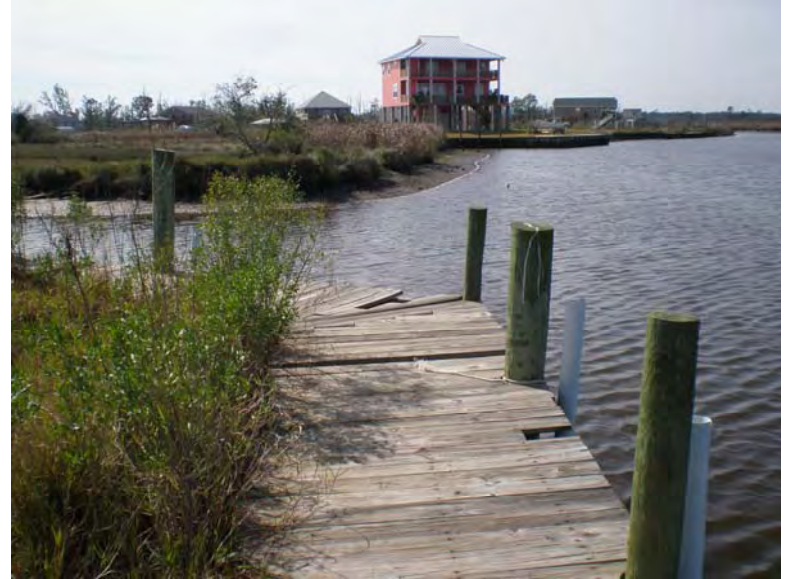
The site inspection photos (Photos 1-14) were taken after the house was demolished. The value of the site specific information is questionable because of the demolition affect. Of interest, most of the plank boards on the dock (Photos 6-7) survived and were not pulled up by wave action. Trees in the area (Photos 11-14) show the affect of wind gusts that crossed during Katrina.

**Photo 7: Looking upstream (SW); boat canal at left**

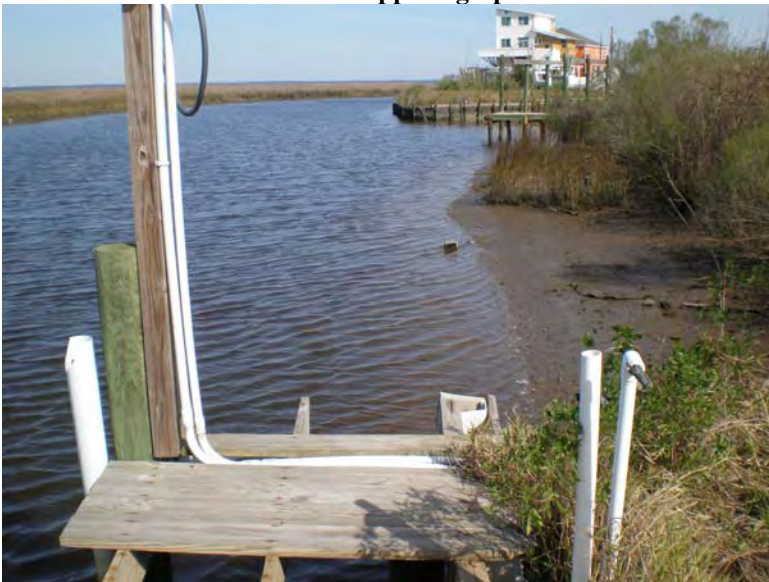
**Photo 6: Looking downstream (NE) towards Jourdan River**

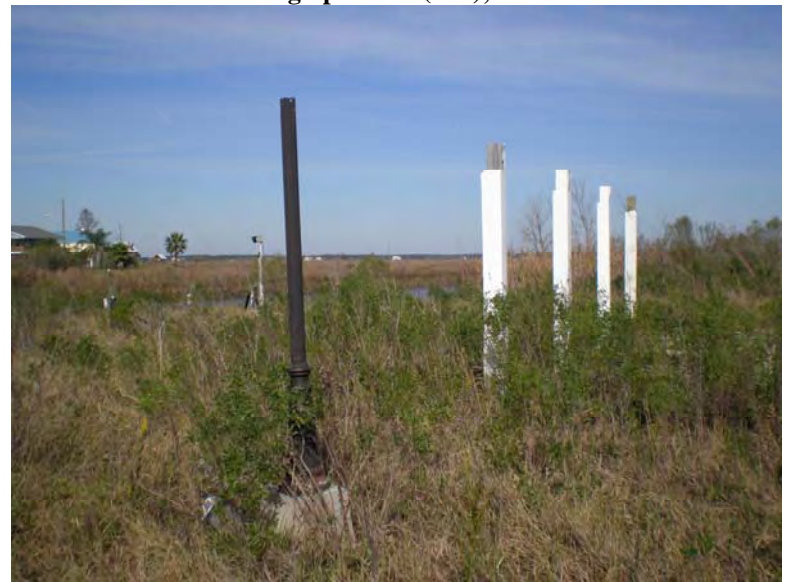
**Photo 8: Surviving lightpole and four timber piles**

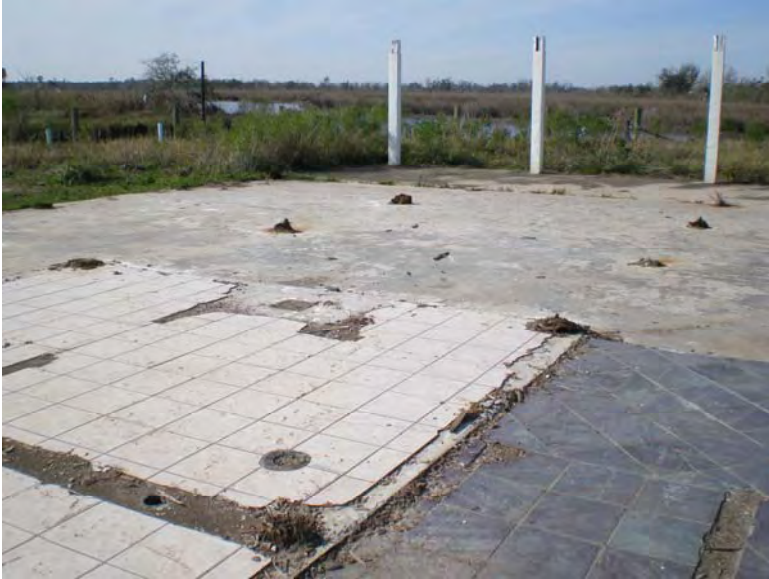
**Photo 9: Looking towards rear of building footprint**

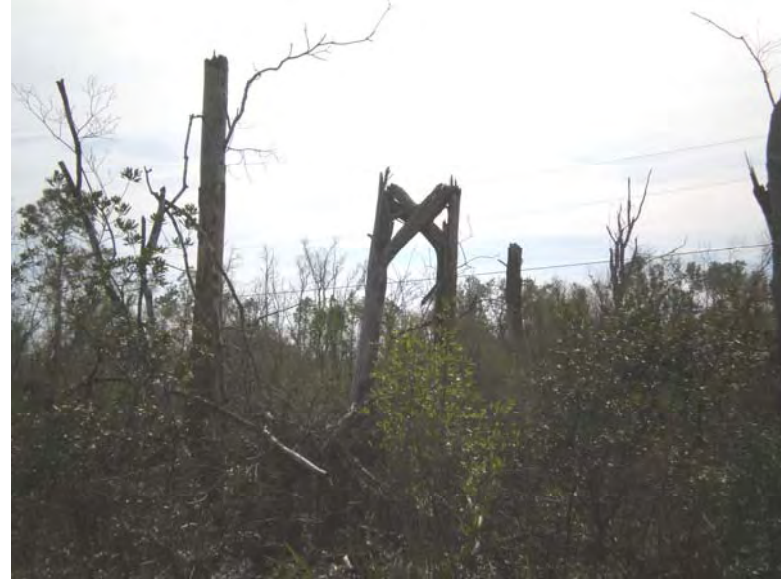
**Photo 11: Snapped tree trunks on Chapman Road**

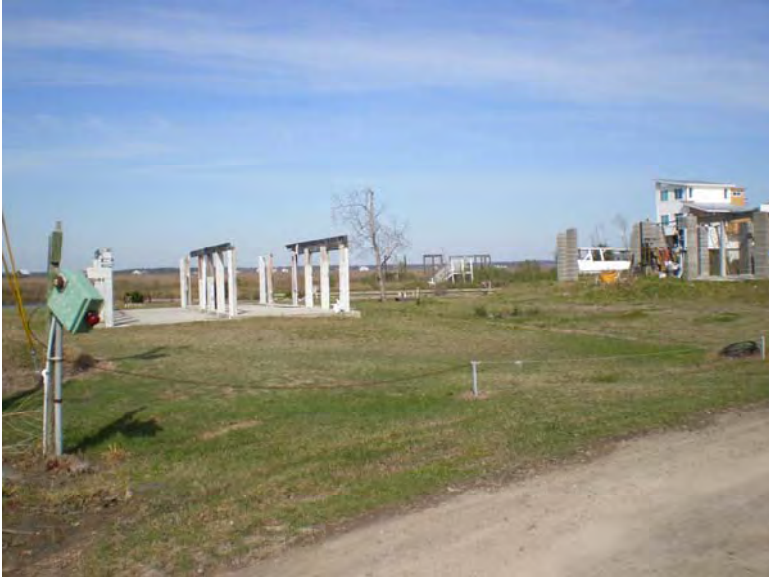
**Photo 10: Remaining slabs NE of Anthony residence**

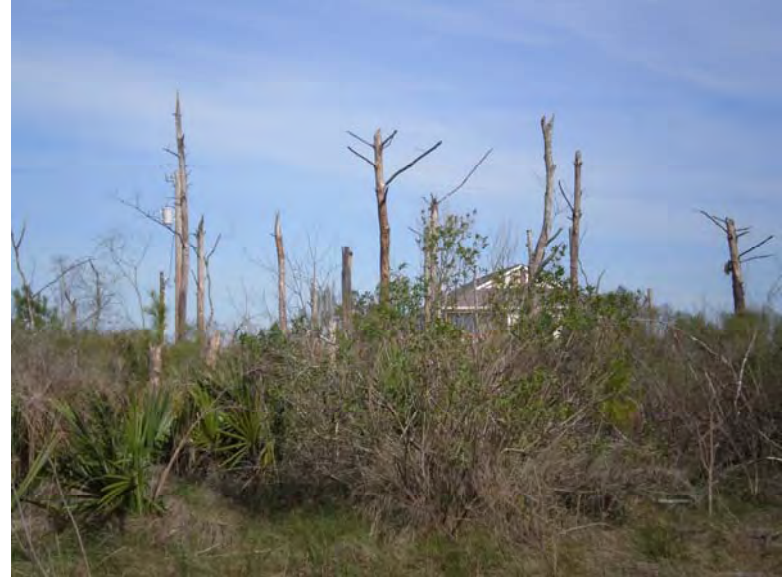
**Photo 12: Denuded tree trunks on Chapman Road**

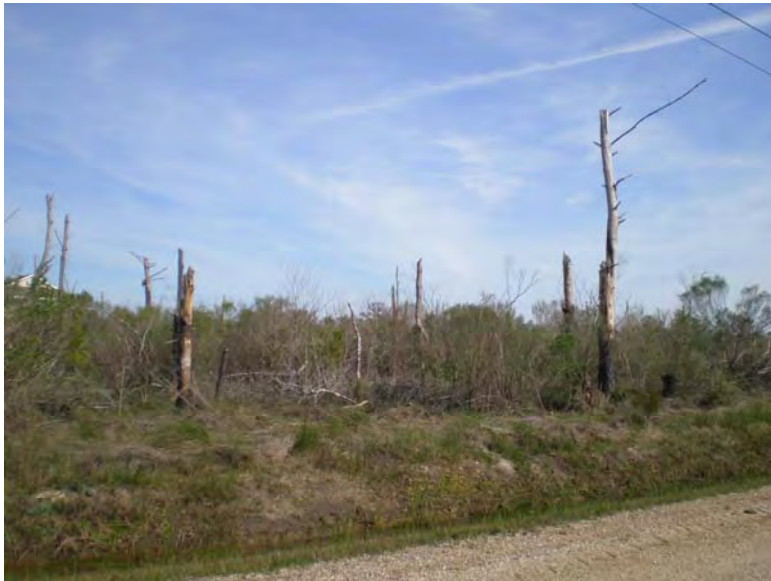
**Photo 13: Denuded tree trunks on Chapman Road**

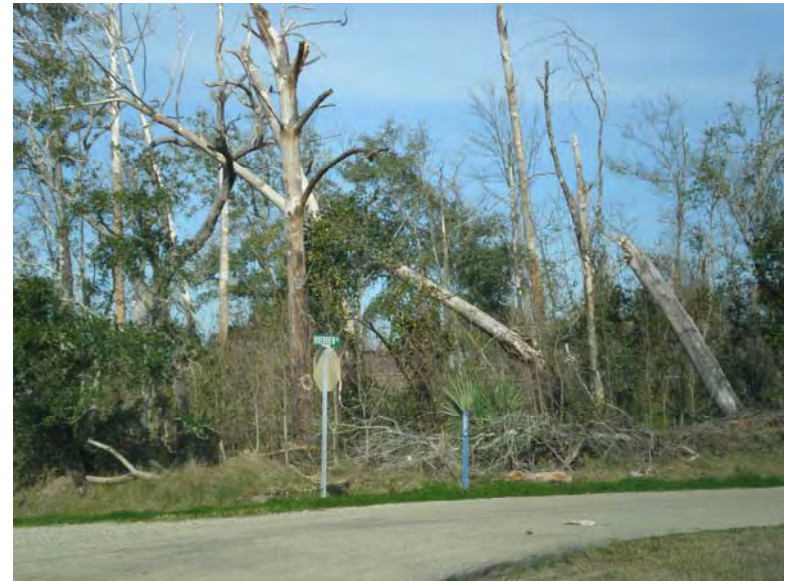
**Photo 14: Uprooted trees on Riverview Road**
