## BUILDING DAMAGE ASSESSMENT

**ANTHONY RESIDENCE  
506 RIVERVIEW ROAD  
BAY ST. LOUIS, MISSISSIPPI 39520**

**AUGUST 29, 2005  
(HURRICANE KATRINA)**

**REPORT NUMBER 90000**

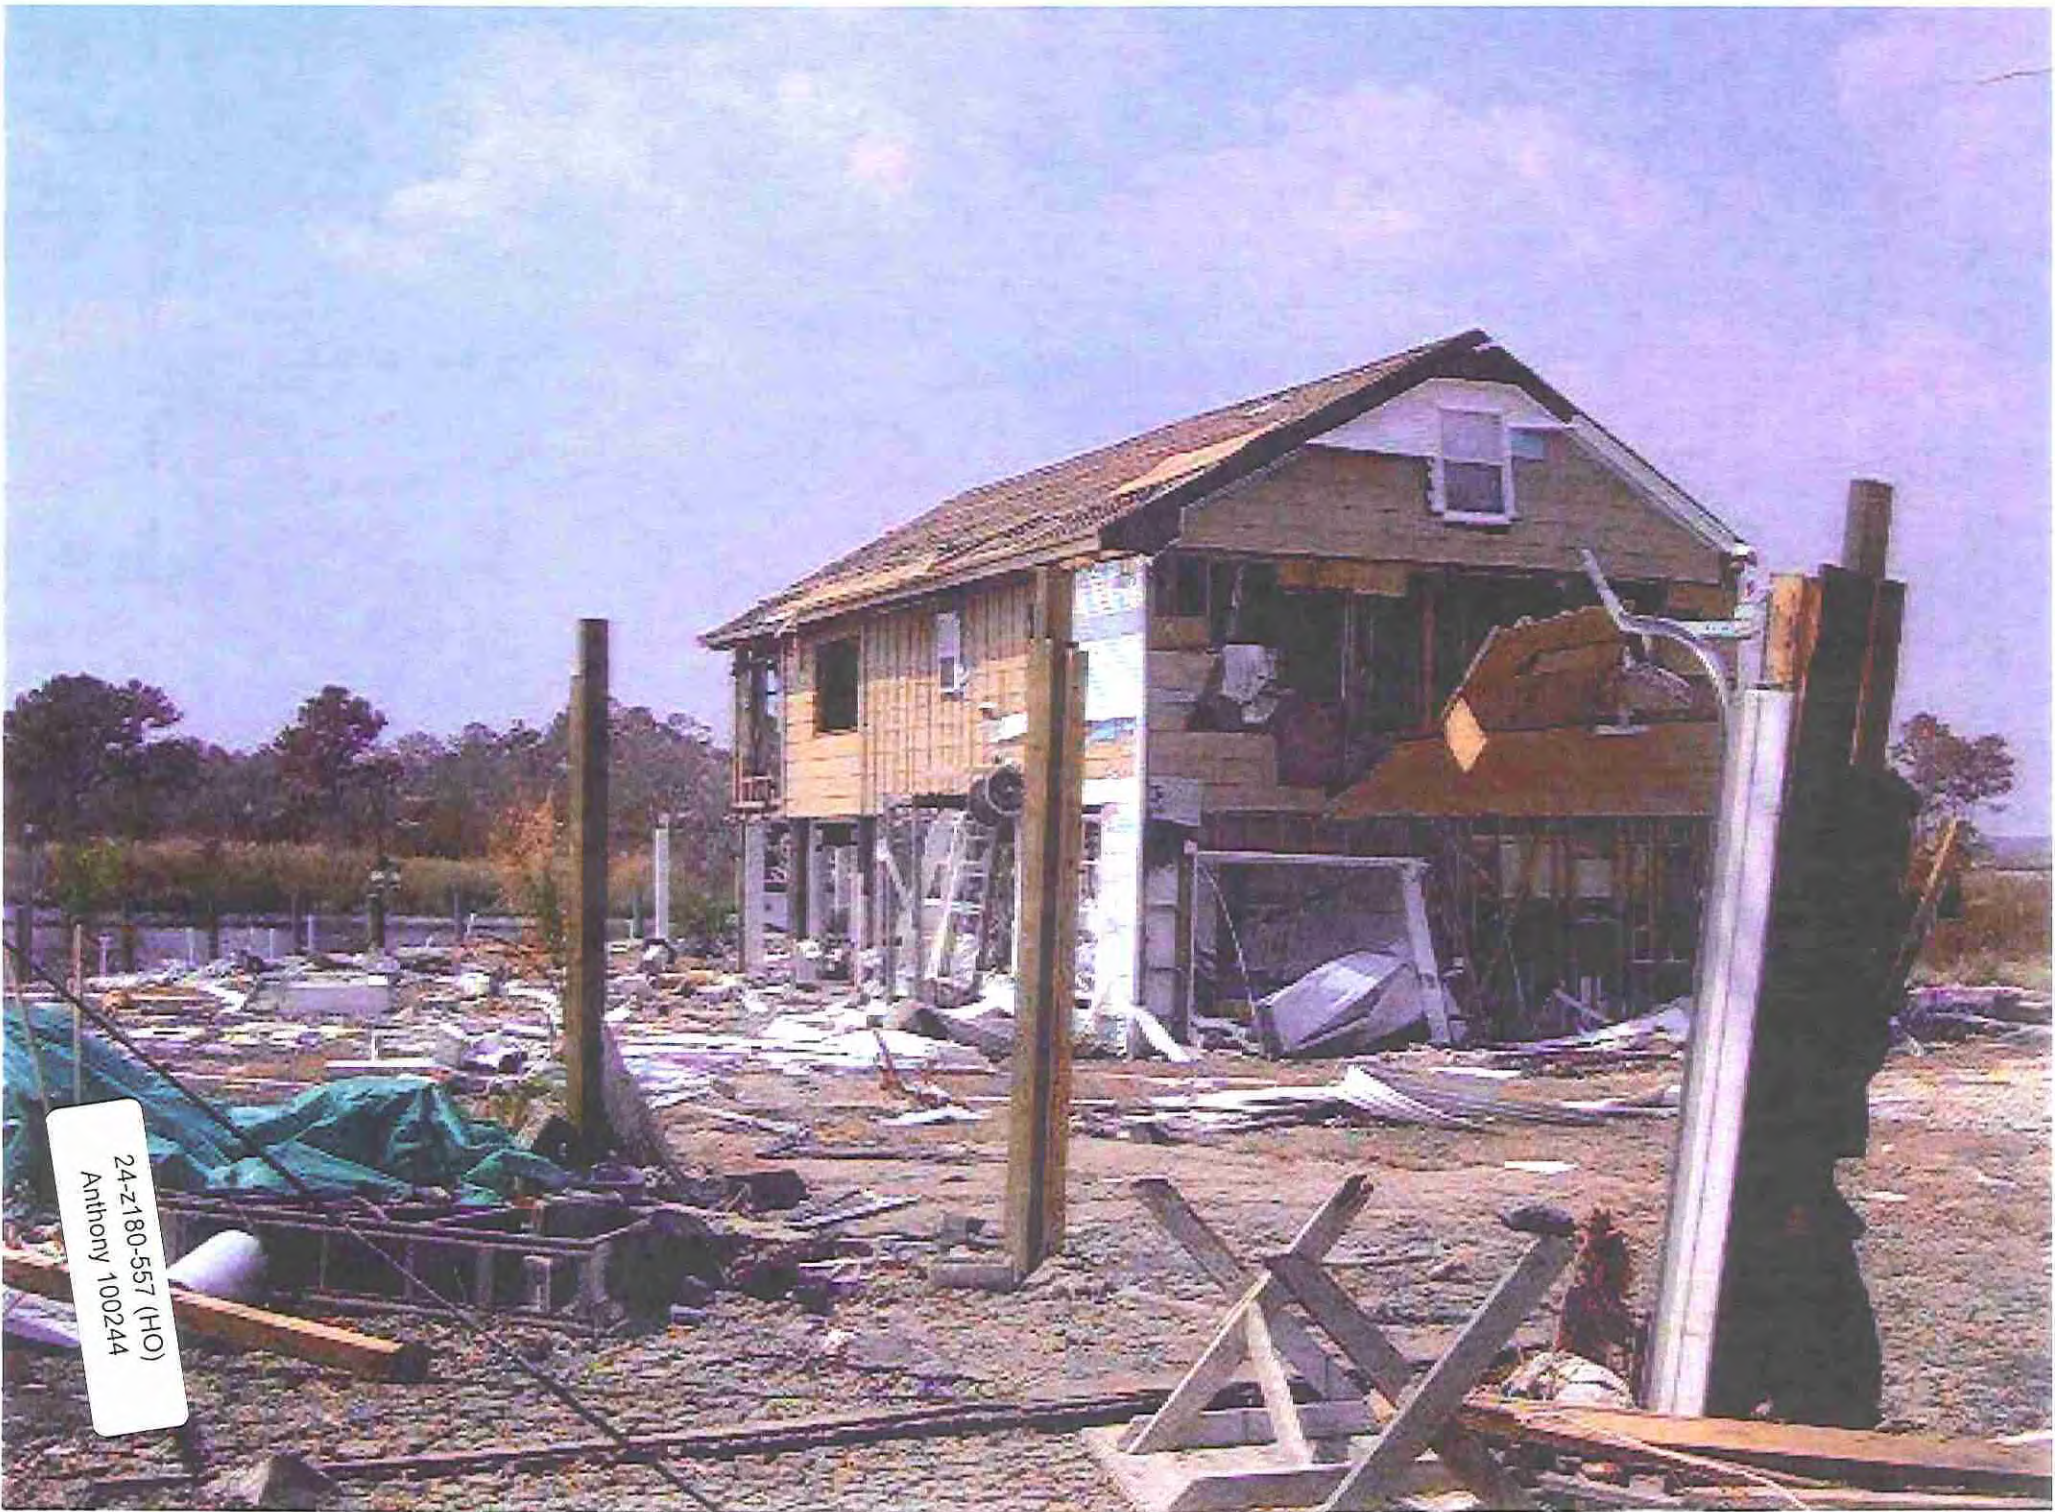
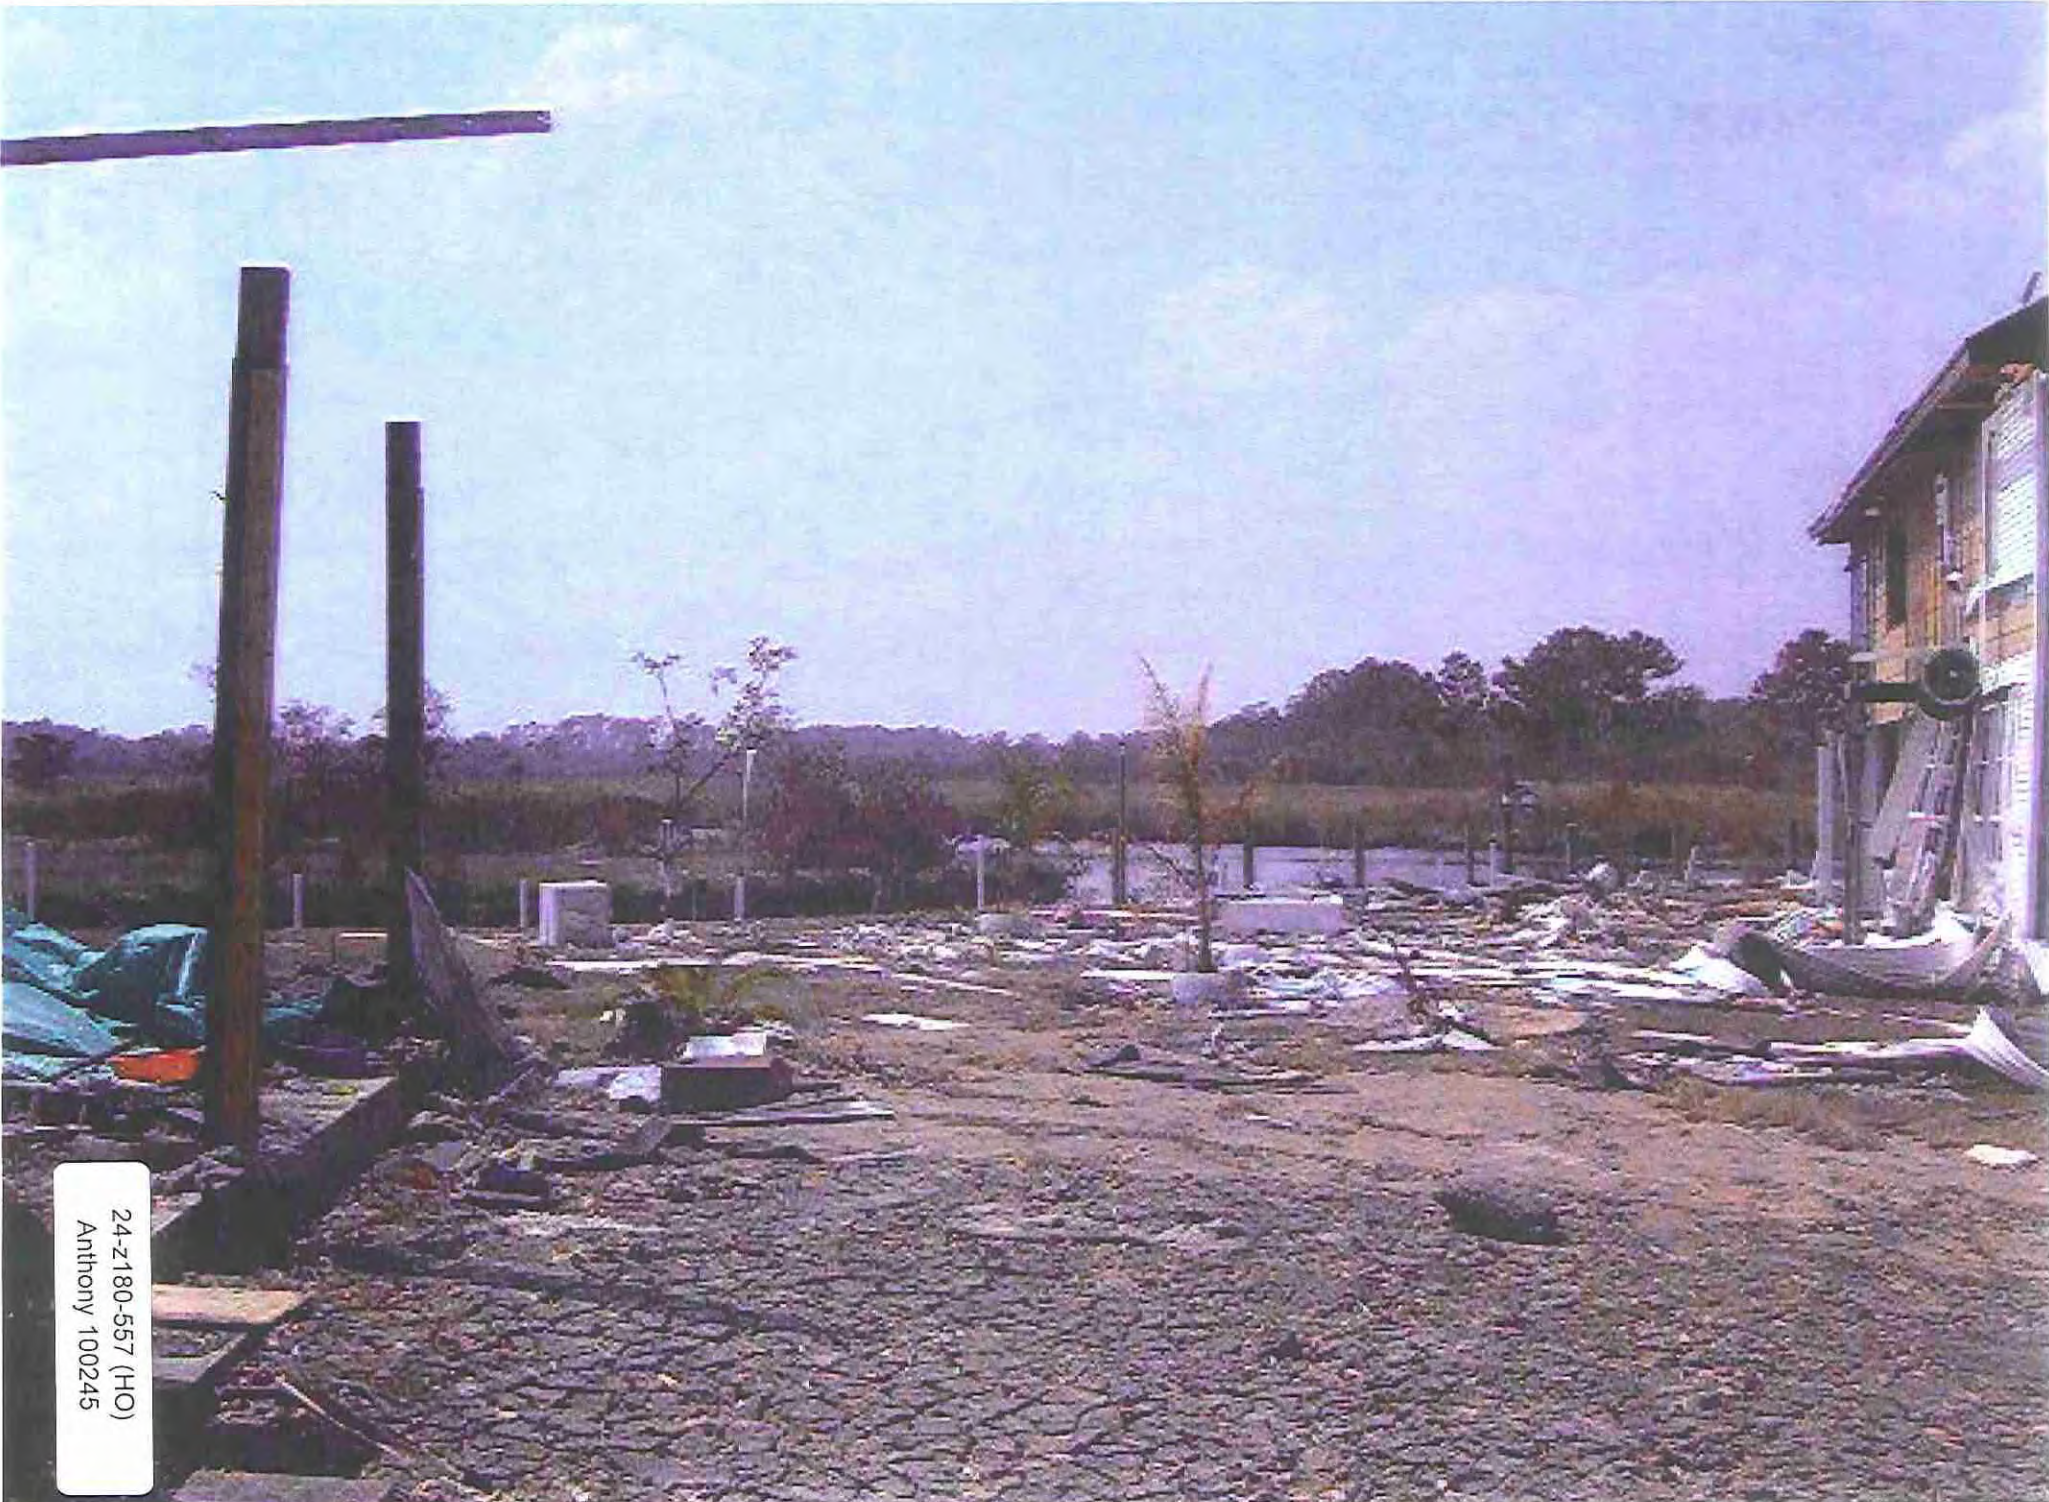
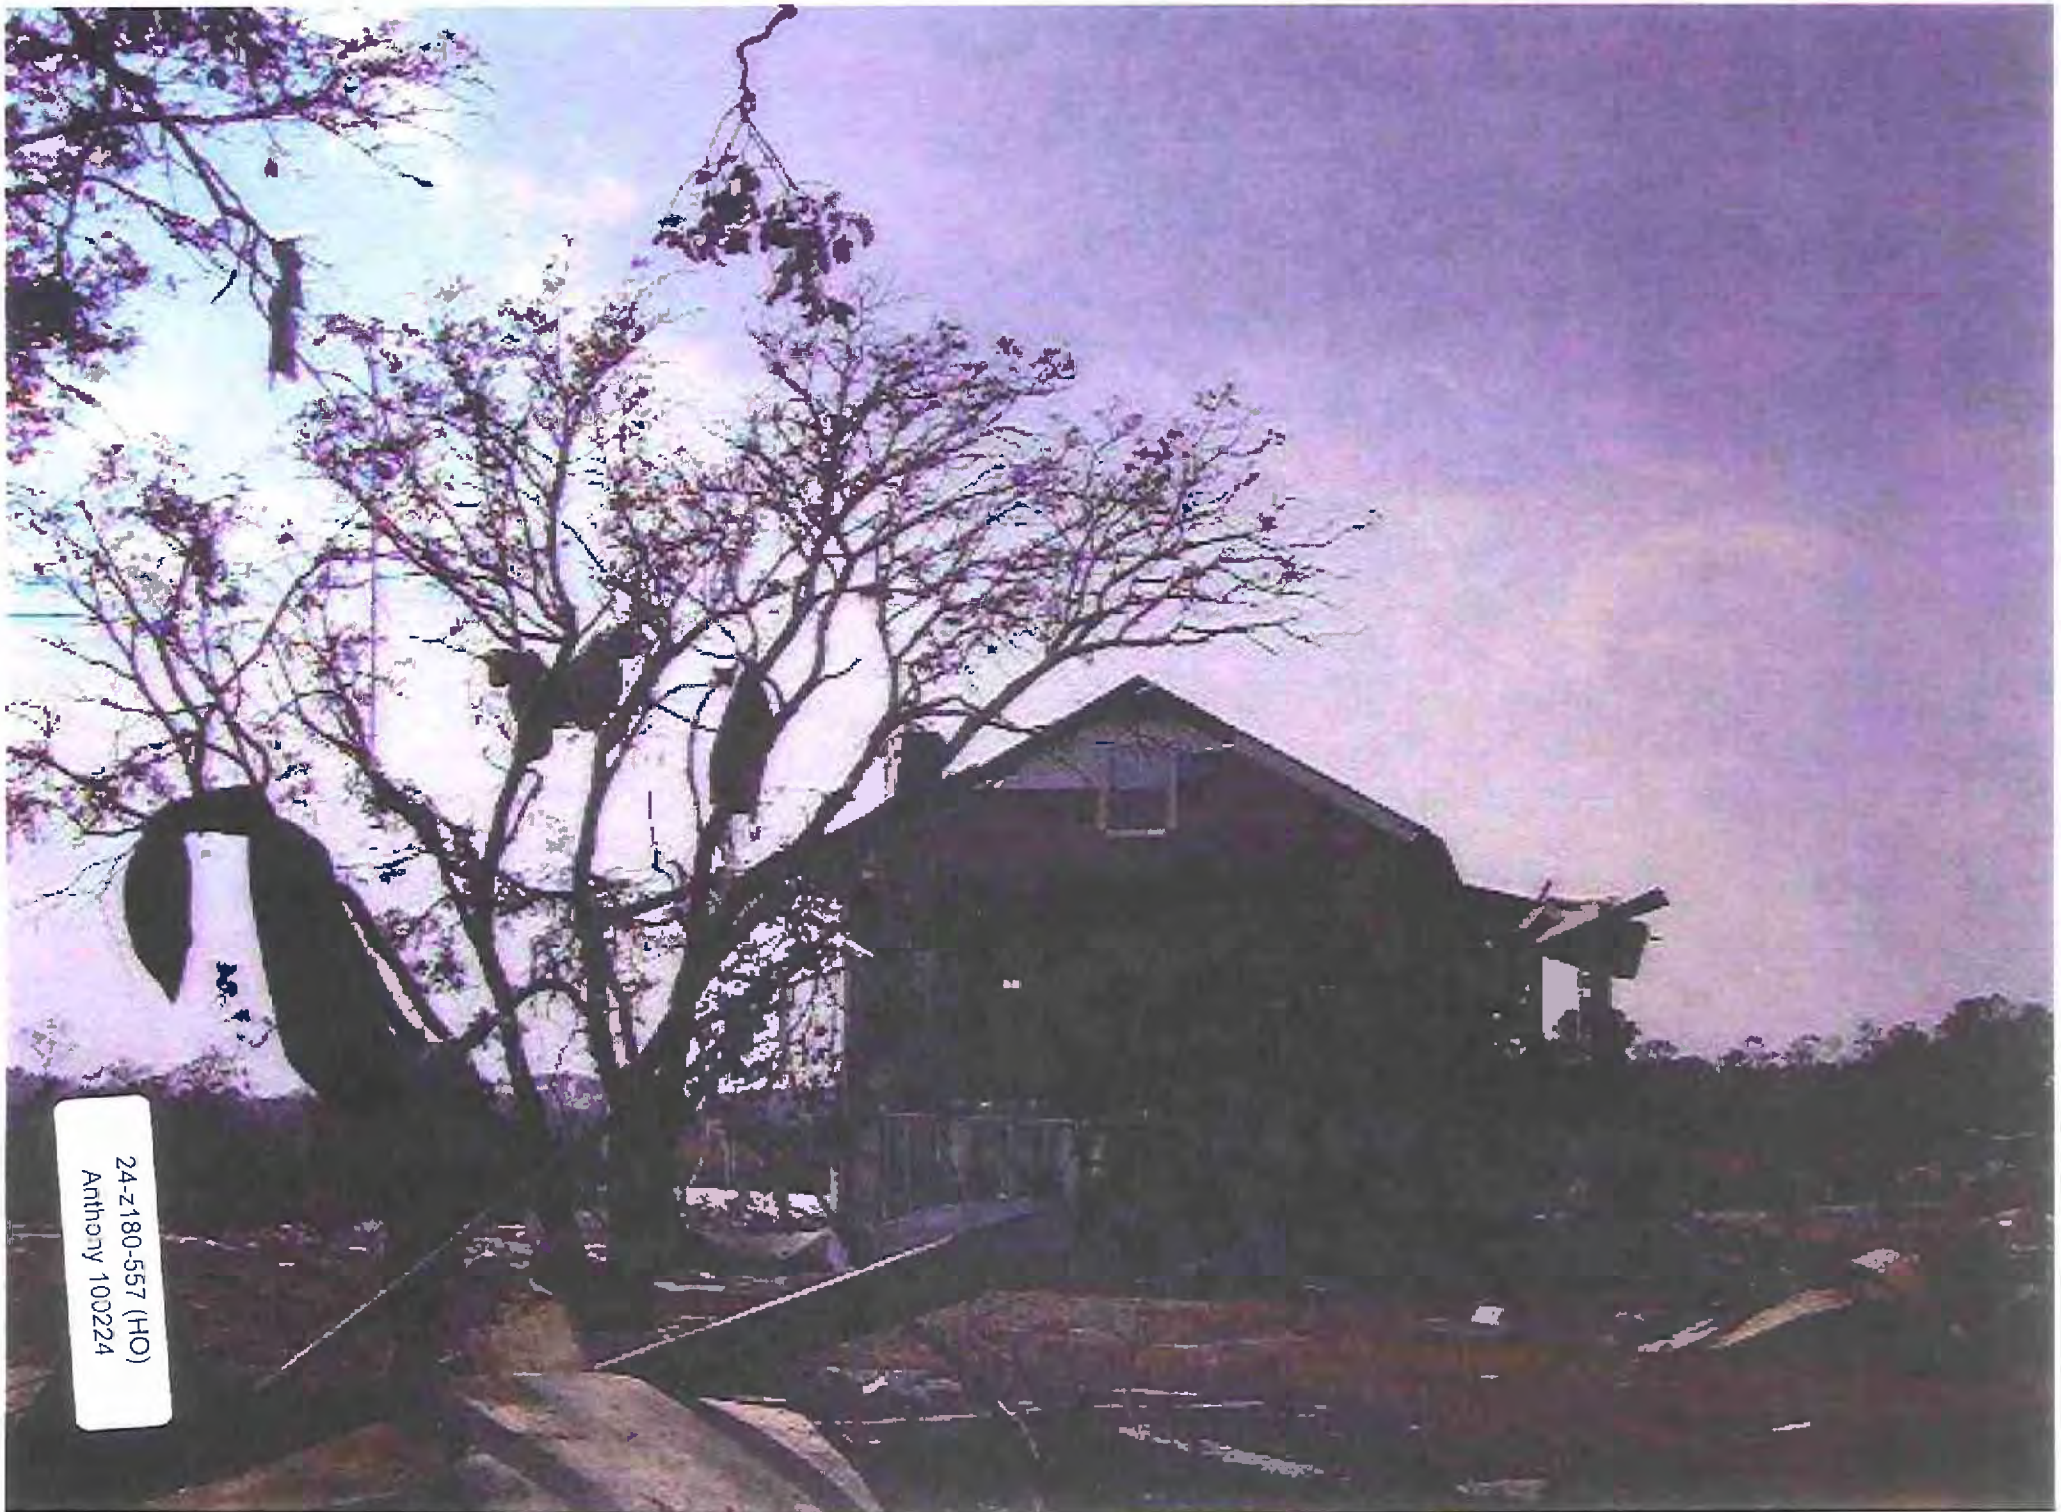
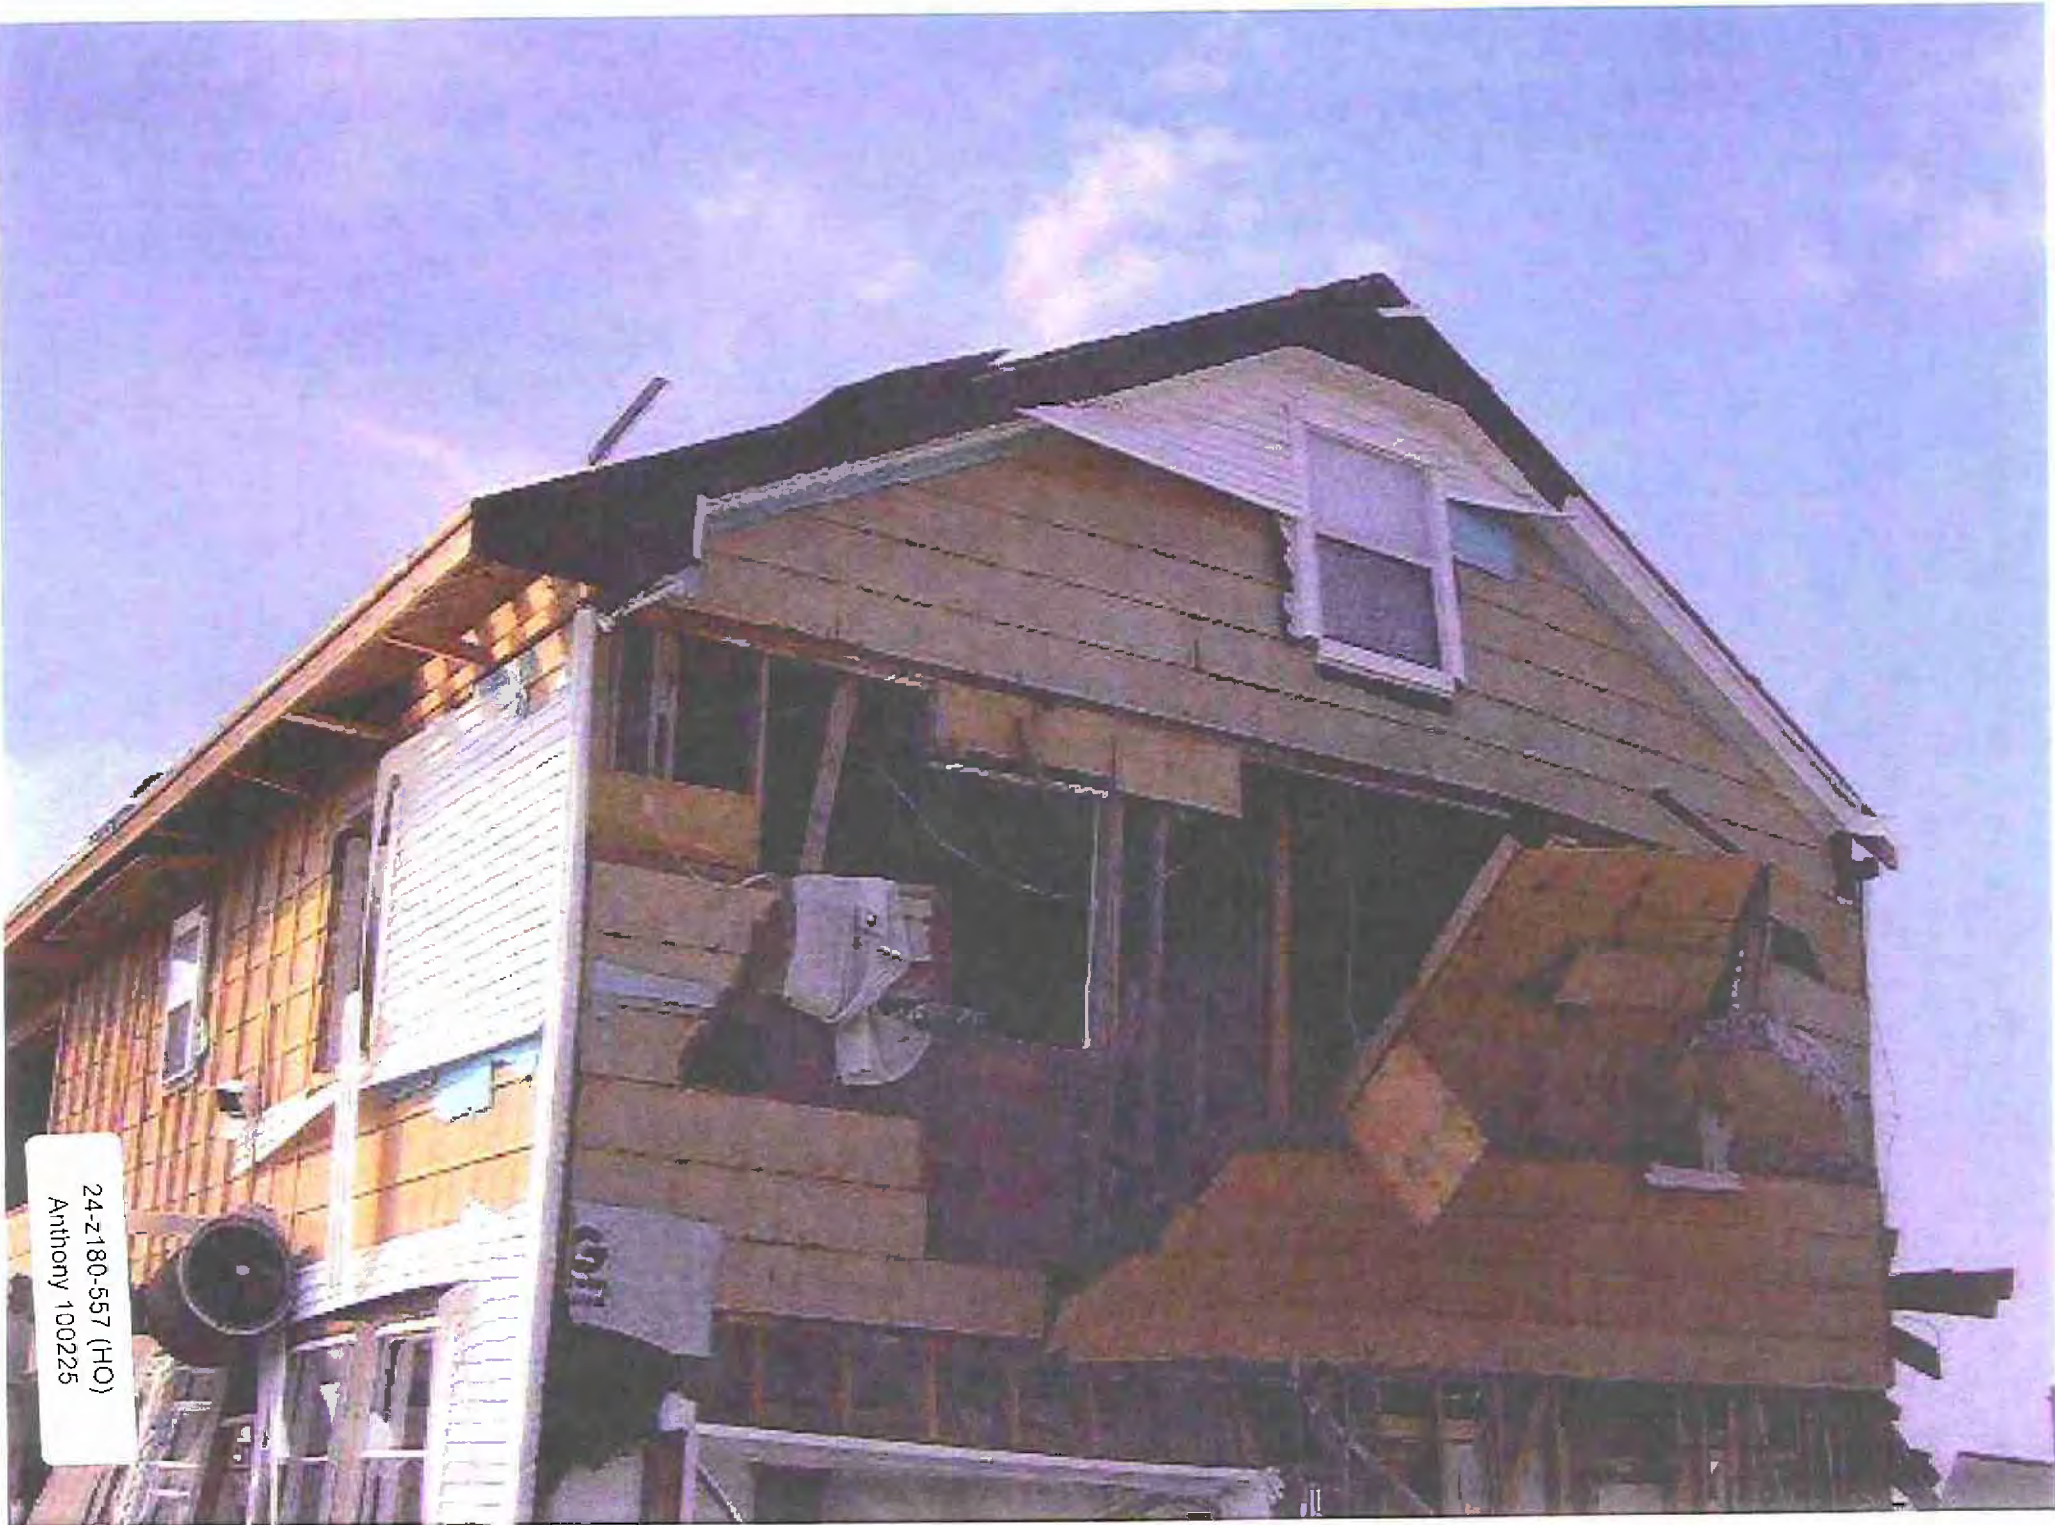
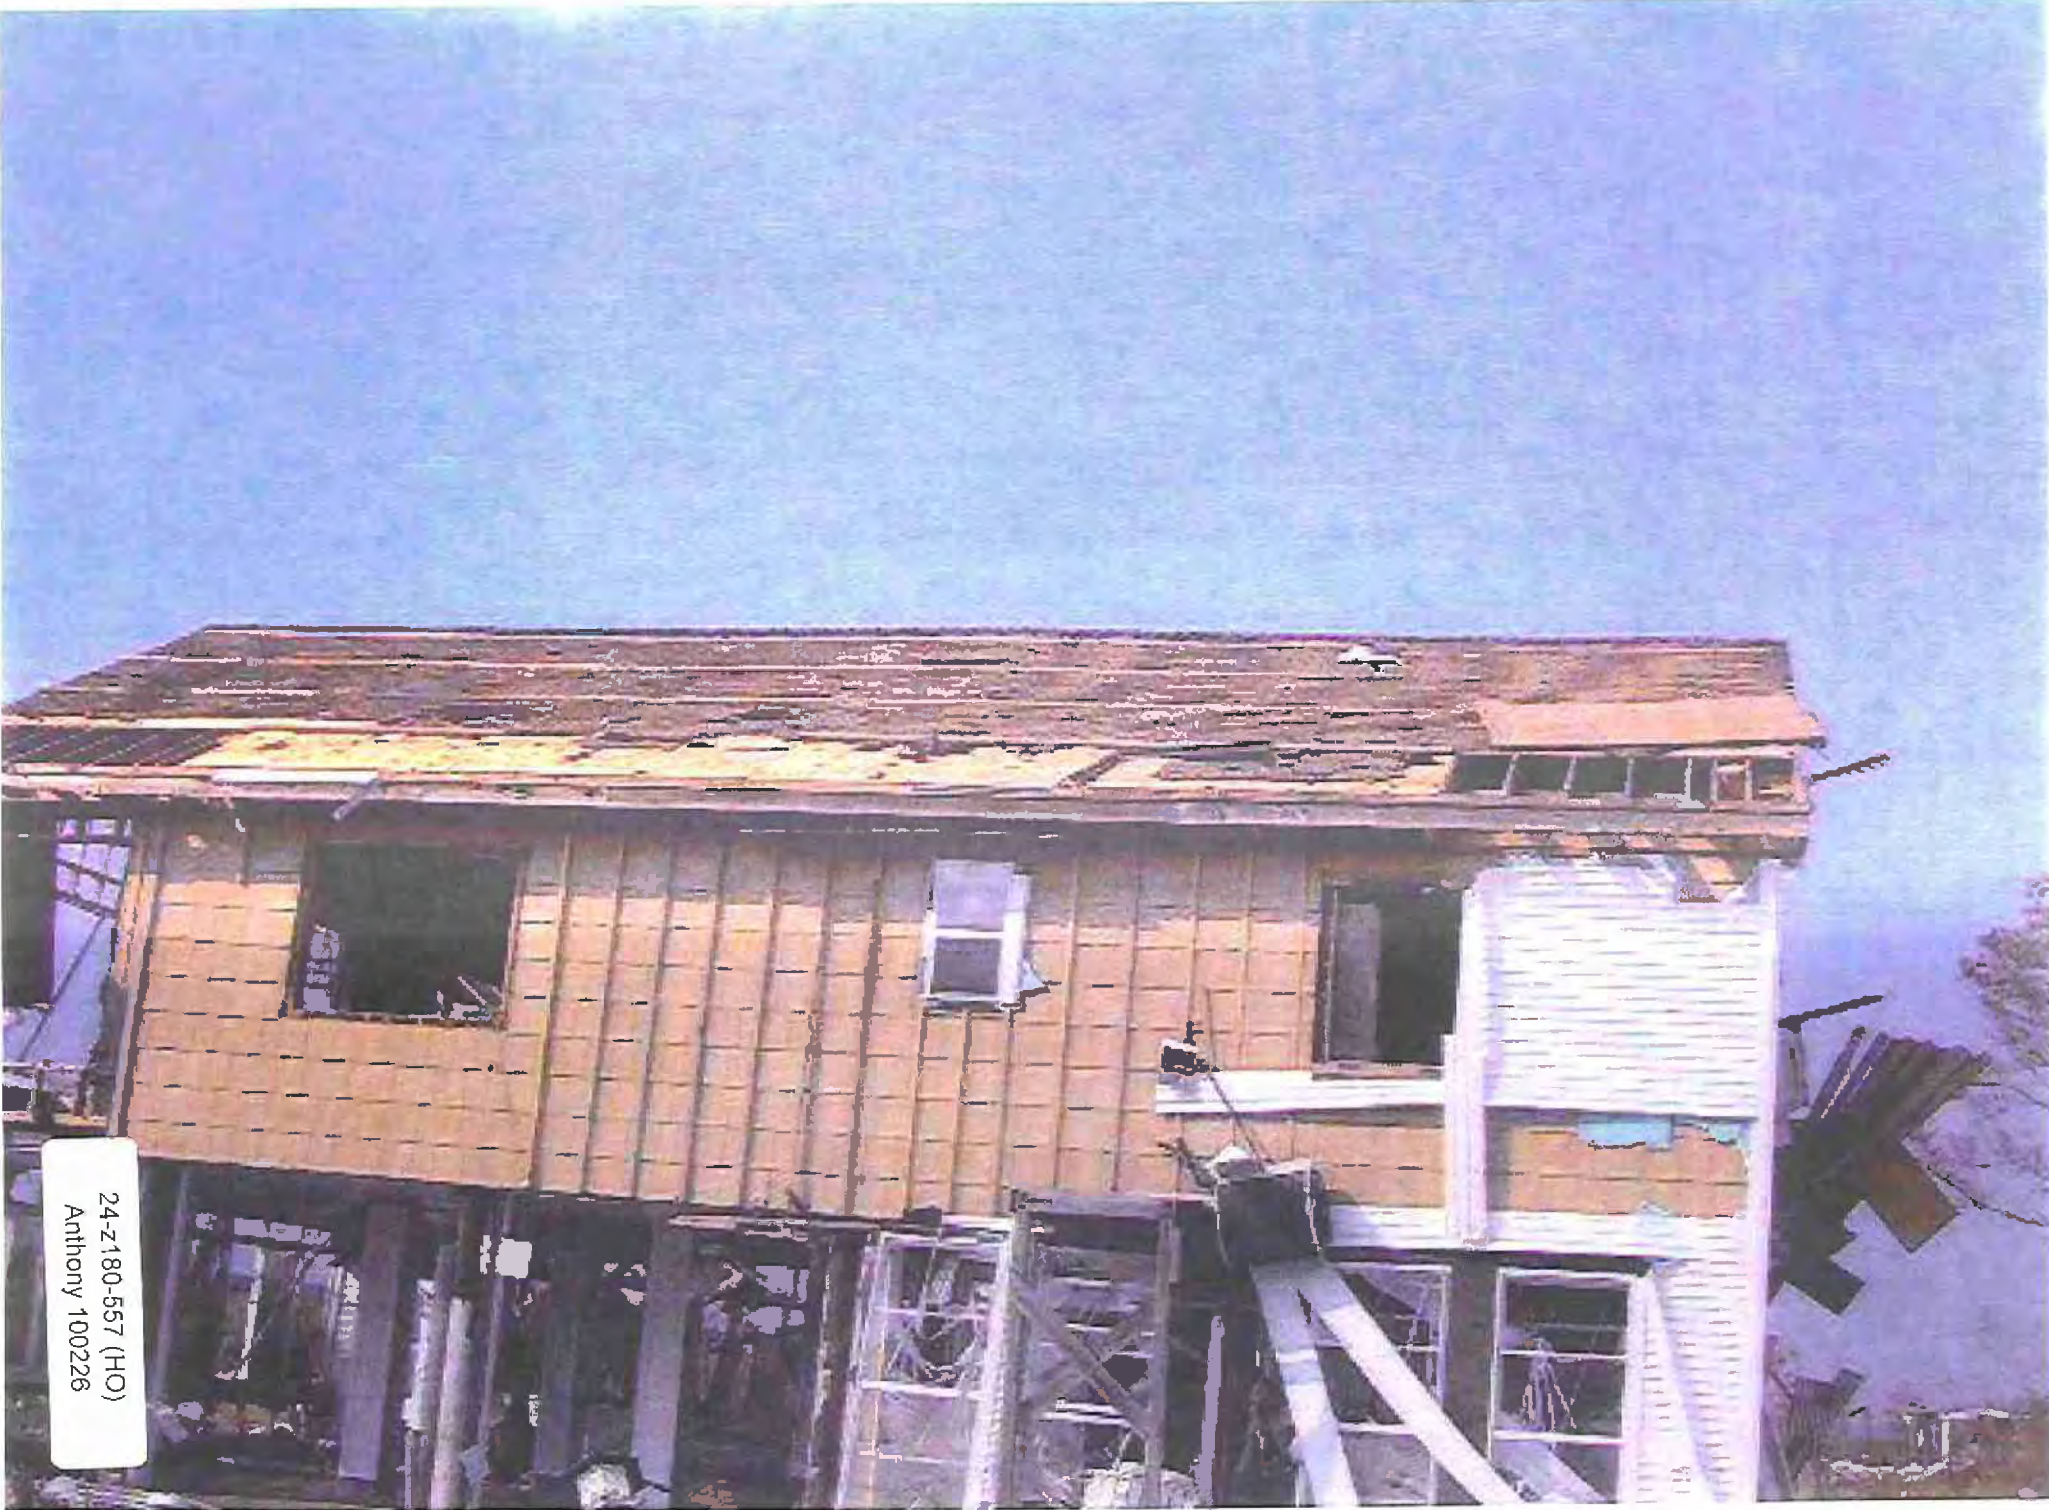
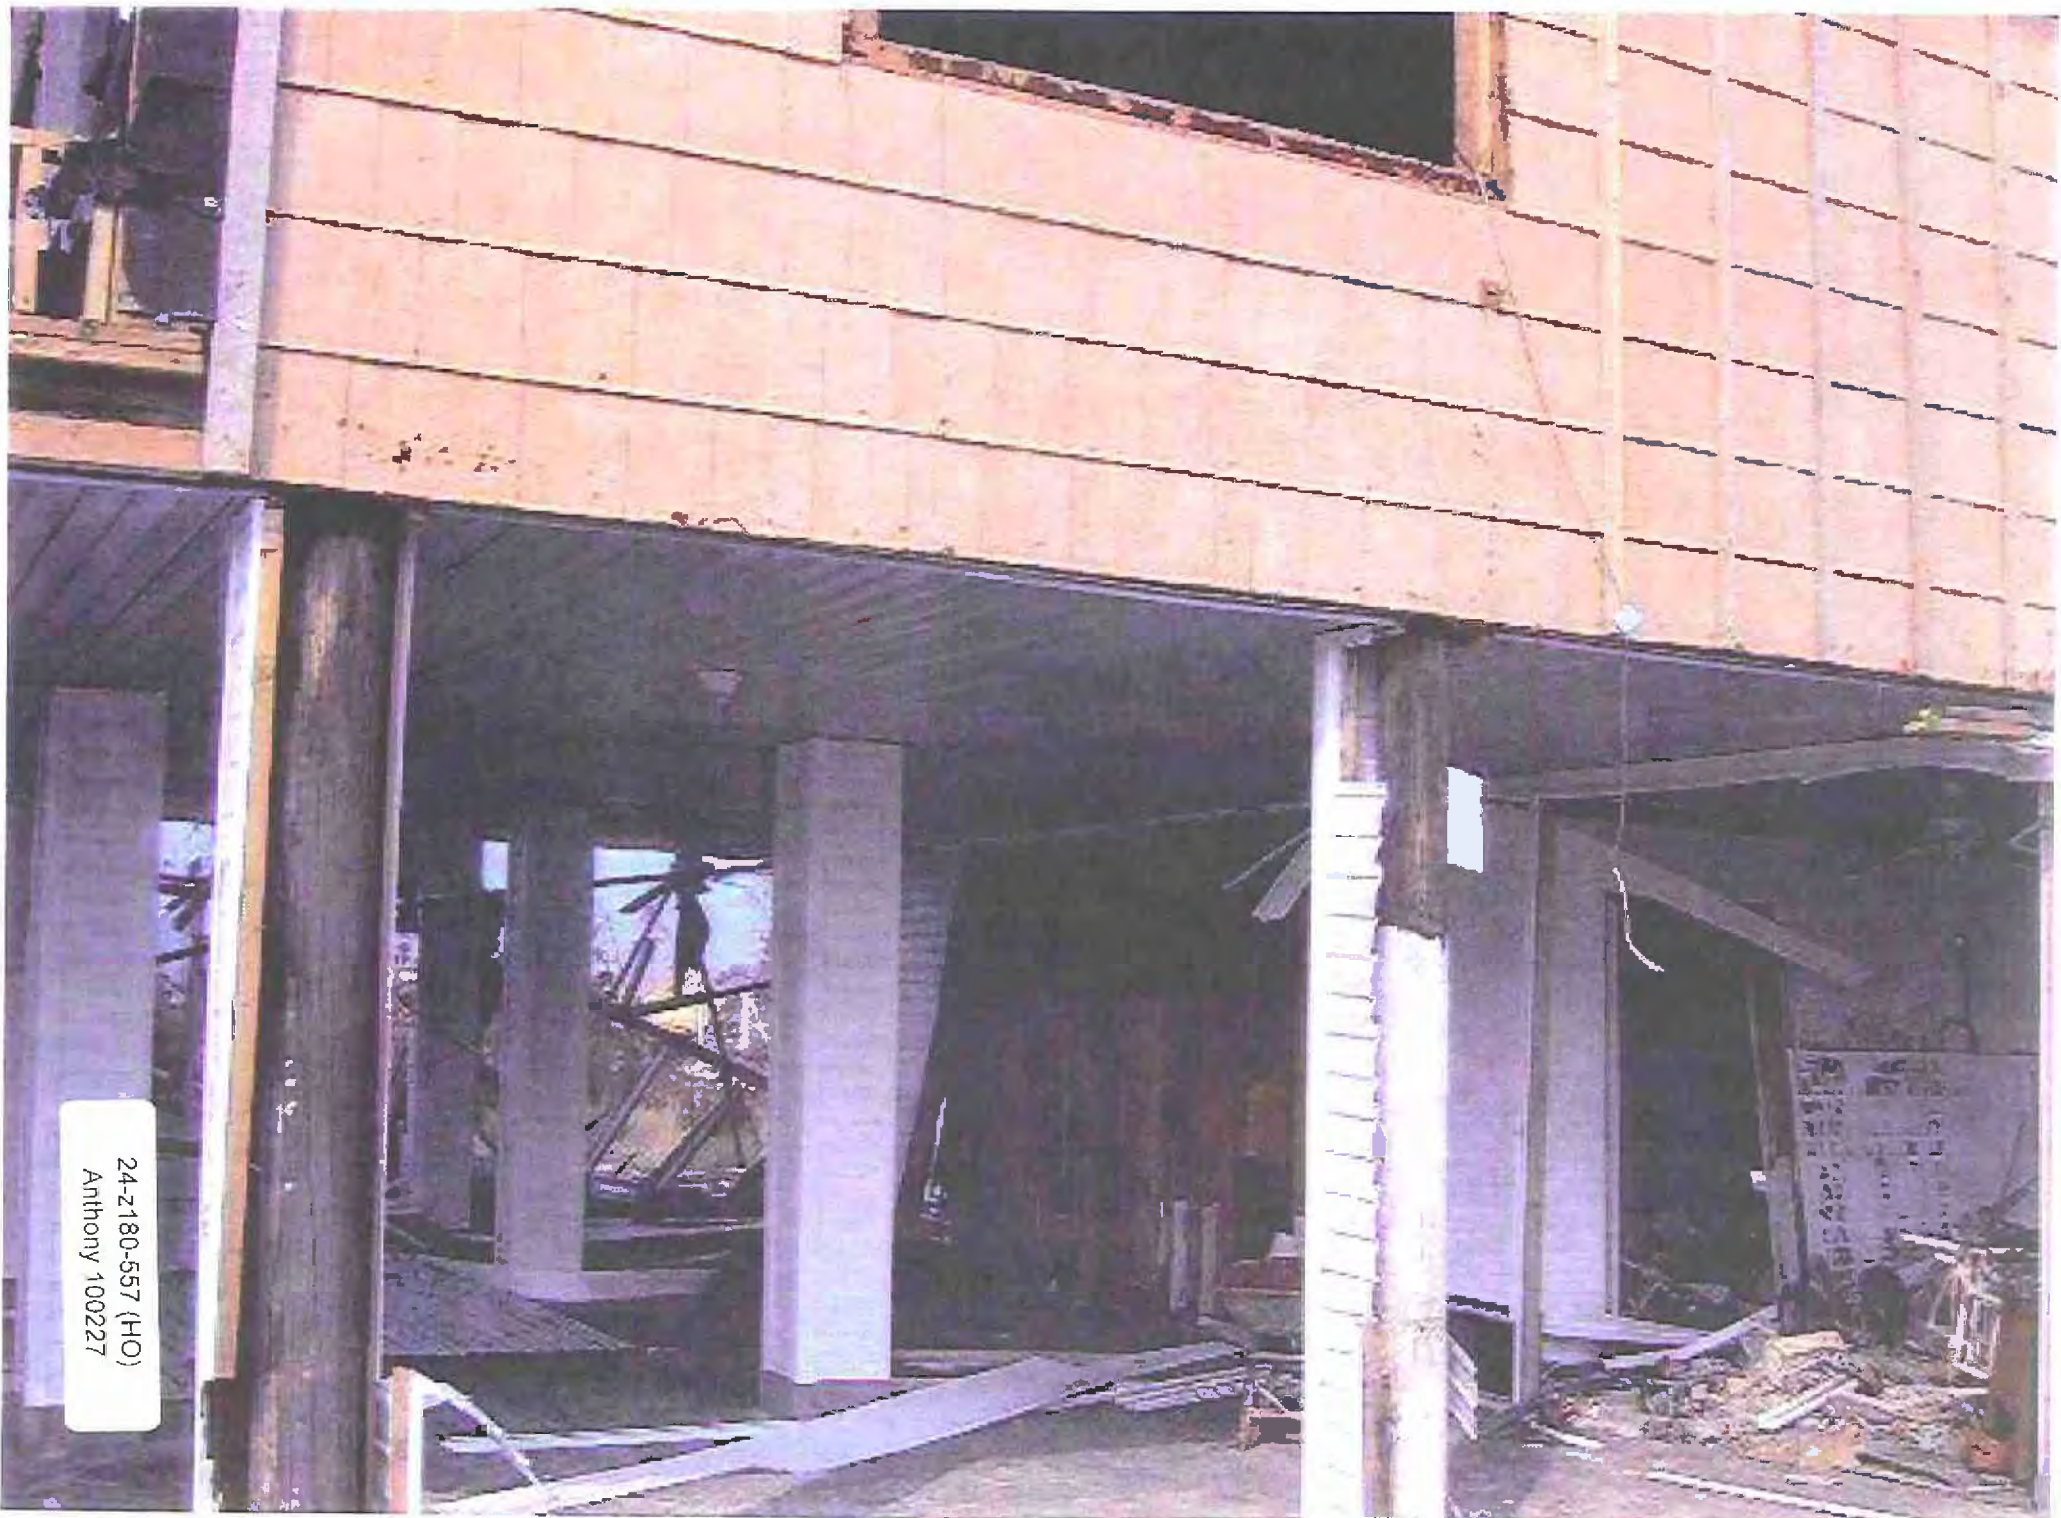
The post-Katrina damage photos in Attachment B show the metal roof removed; the battens over the shingled roof covering remained. At some locations shingles are missing exposing the building paper; at other locations the roof sheathing is missing.

The siding is removed from most locations; the battens over the original cladding remained. Under the house, the ceiling under the elevated structure and the overhead fans remain intact. This indicates that storm surge rose without any significant wave activity, collapsing the break-away walls and covering the ceiling and overhead fans before wind could attack these components.

The roof over the screen-in patio was removed by wind, exposing the original structure to wind and wind-driven rain. The metal roof over the original structure and portions of the roof deck also were removed by wind allowing wind and wind-driven rain to penetrate the structure.
