**IN THE UNITED STATES DISTRICT COURT  
FOR THE SOUTHERN DISTRICT OF MISSISSIPPI  
SOUTHERN DIVISION**

**STATE FARM FIRE AND CASUALTY COMPANY'S  
MOTION FOR PARTIAL SUMMARY JUDGMENT**

**FITZPATRICK REPORT**

This report presents information about Katrina's wind and storm surge elements at 506 River View Road in Bay St. Louis, MS. Section 1 provides background information on the physics of the storm surge. Section 2 describes Katrina's wind field, its storm surge, and the timing of both events. Section 3 summarizes the findings.

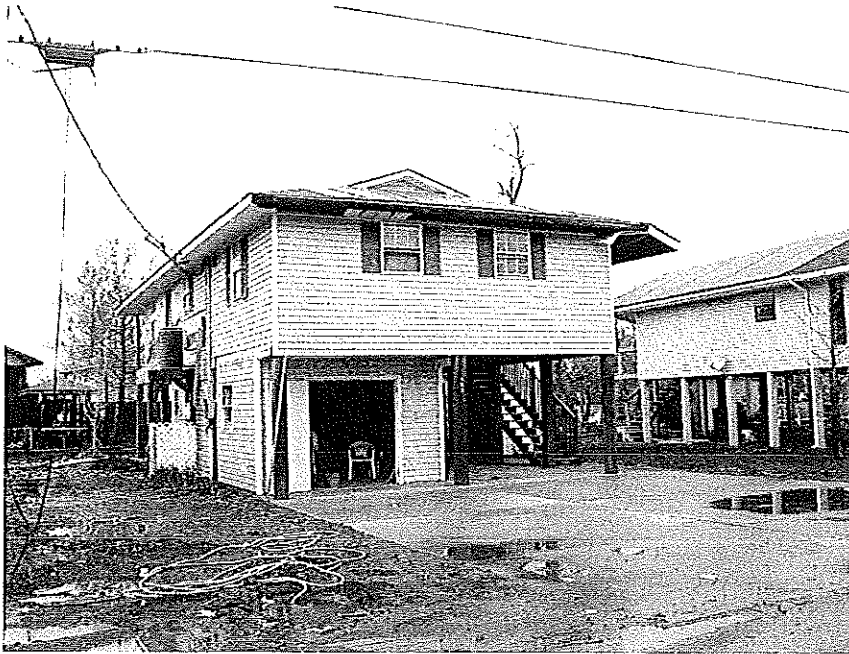
**Photo A**

View of the front elevation of the elevated (1) story single family residence located at 903 Deer Drive within Hancock County, Mississippi. The front elevation faces in a generally southerly direction. We noted that the residence was a conventional timber framed pile supported structure with the elevated first floor constructed over a concrete cast-in-place slab on grade. We noted missing fascia, soffit, and finish roof shingles at the front elevation roof slope.

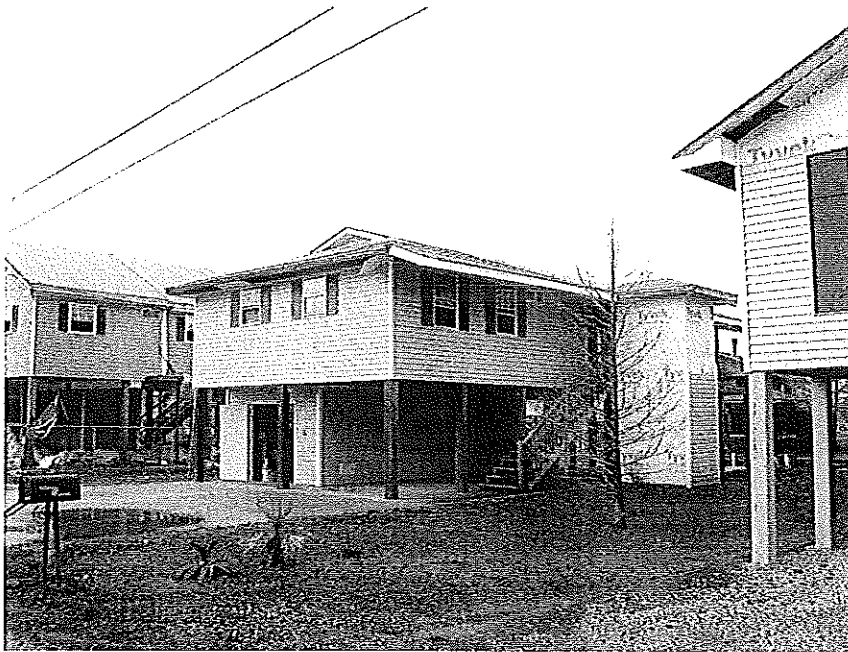
**Photo B**

View of the right elevation of the single family residence located at 903 Deer Drive. The right elevation faces in a generally easterly direction. We noted that the ground floor consisted of storage and a carport, with stairs and an elevator personnel access to the first floor. We noted missing and loose soffits as well as vinyl siding on the upper part of the elevator shaft.

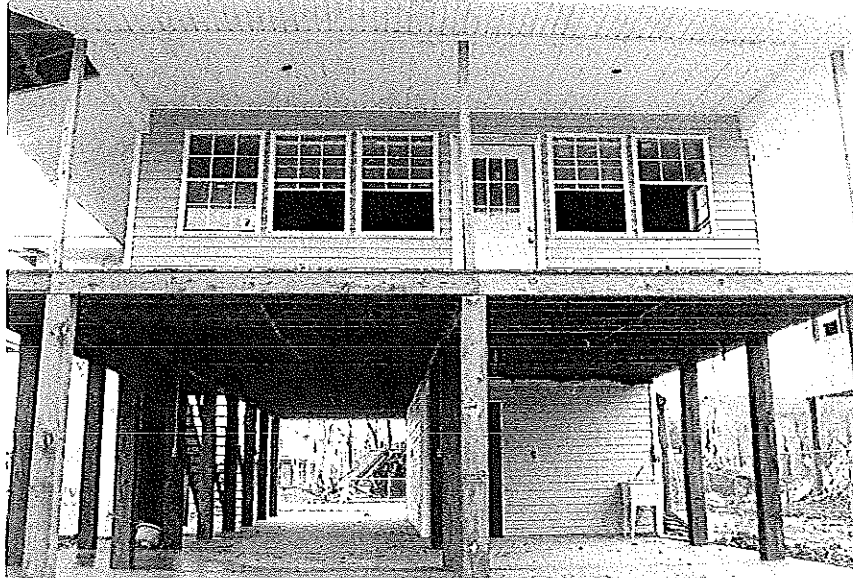
**Photo C**

View of the rear elevation of the single family residence located at 903 Deer Drive. The rear elevation faces in a generally northerly direction. We noted soffit damage to the underside of the roof overhang at the rear corner of the right elevation. We also noted the absence of handrails, screens, or guardrails at the first floor elevated deck.

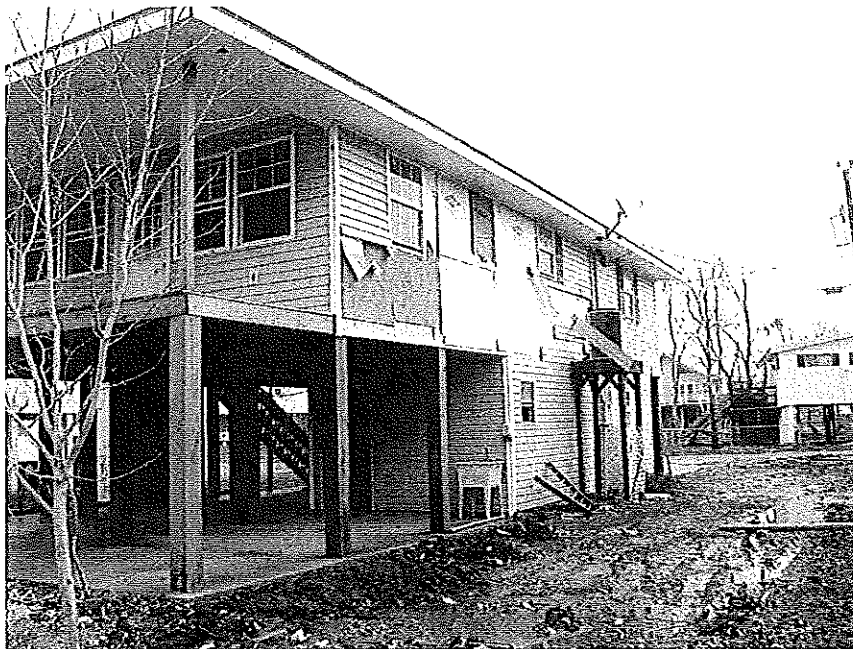
**Photo D**

View of the left elevation of the single family residence located at 903 Deer Drive. The left elevation faces in a generally westerly direction. We noted a significant amount of missing horizontal vinyl siding above the elevated first floor of this elevation. We also noted lattice screening still in place at grade.

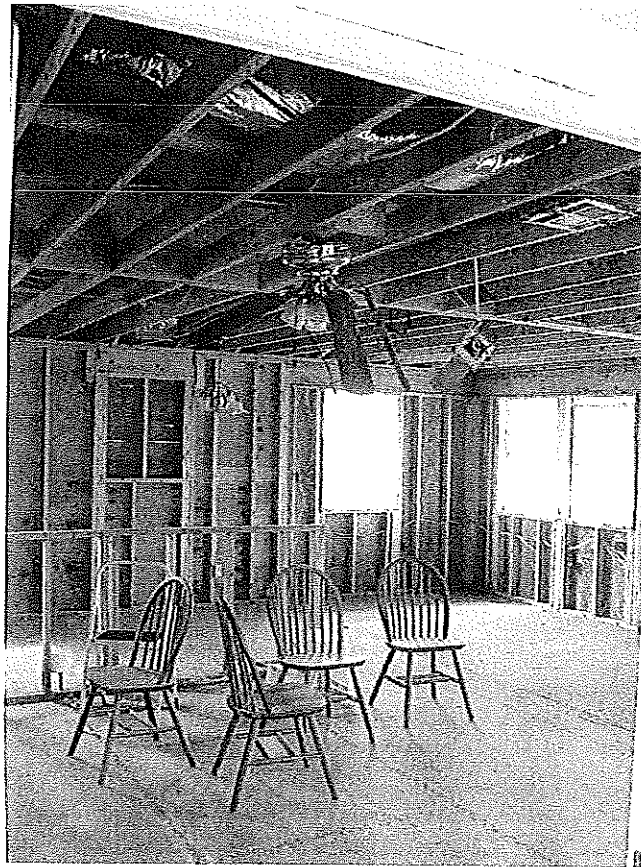
**Photo E**

Interior view of the rear corner of the left elevation of the single family residence located at 903 Deer Drive. We noted that the interior finishes had been removed and the site cleaned up. However, we noted water in the heating system ducts and a damaged ceiling fan.

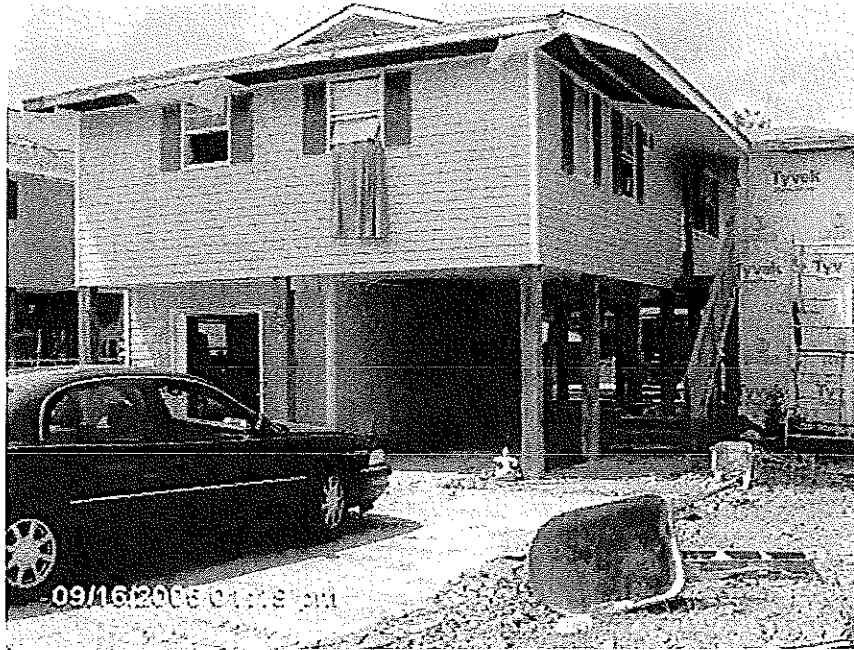
**Photo F**

View of the front and right elevations of the residence located at 903 Deer Drive. Missing soffits on both elevations as well as missing fascia were noted on the front elevation. Note the elevator shaft was under construction along the right elevation.

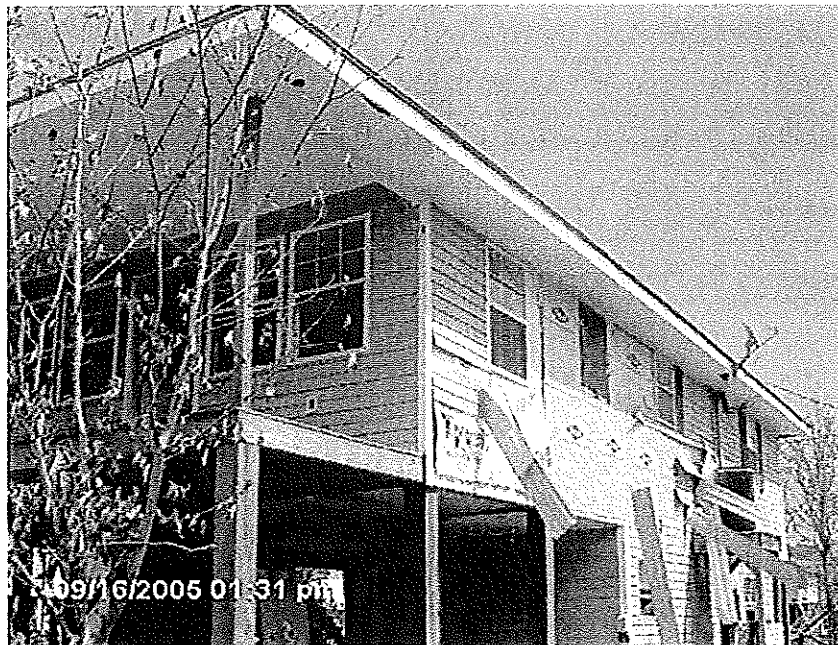
**Photo G**

View of the left elevation of the residence located at 903 Deer Drive. A satellite dish attached to the roof eave was noted to be still intact. Missing or loose vinyl siding was noted along the left elevation of the residence.

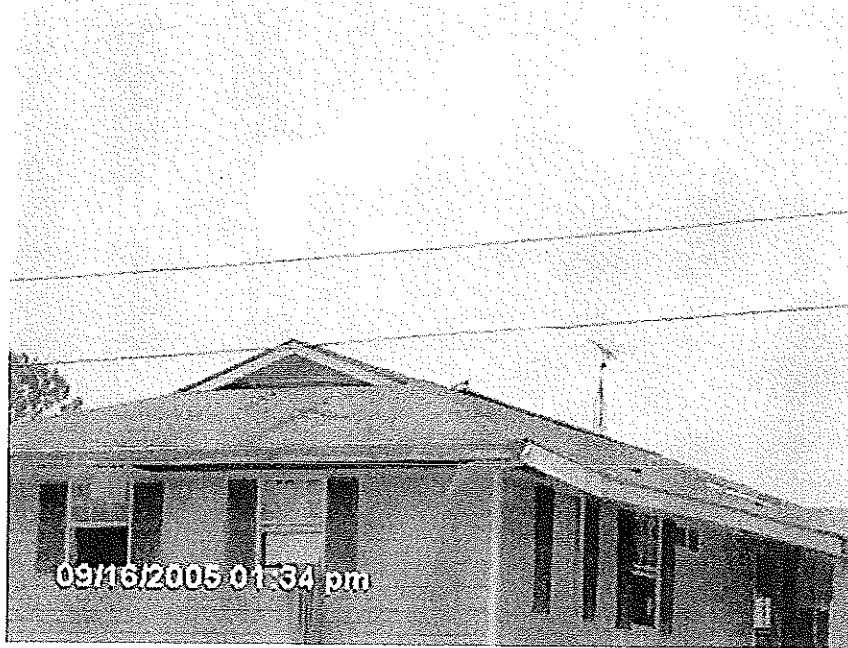
**Photo H**

View of the front and right elevation roof slopes of the residence located at 903 Deer Drive. Areas of missing shingle tabs on the front slope and missing shingle tabs, shingles, and felt paper on the right elevation were noted.

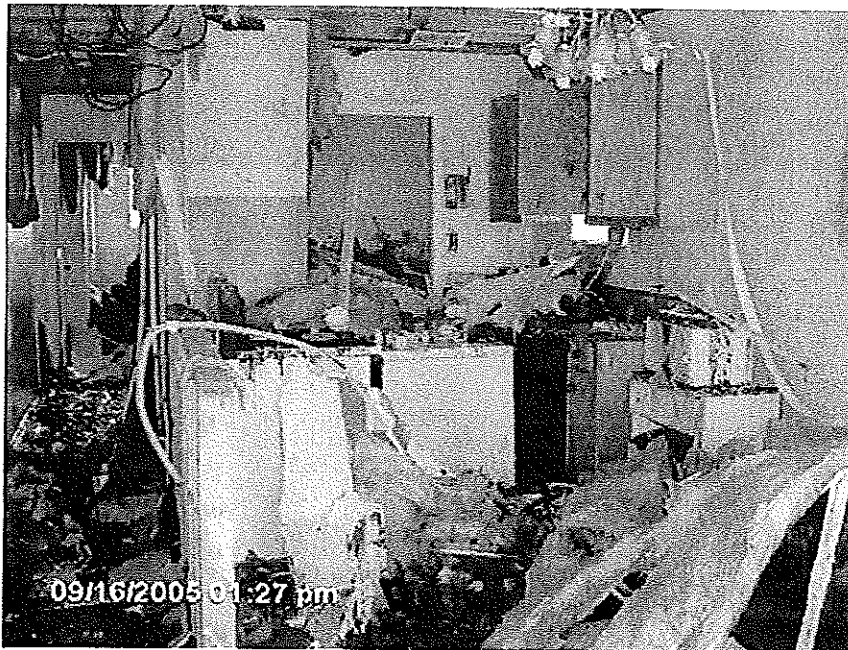
**Photo I**

Interior view of the kitchen on the left elevation of the elevated first floor of the residence located at 903 Deer Drive. The ceiling had generally collapsed within the residence with mud on the ceiling HVAC vents. Damaged finishes were noted on the walls with mud on the tops of the appliances and tables.

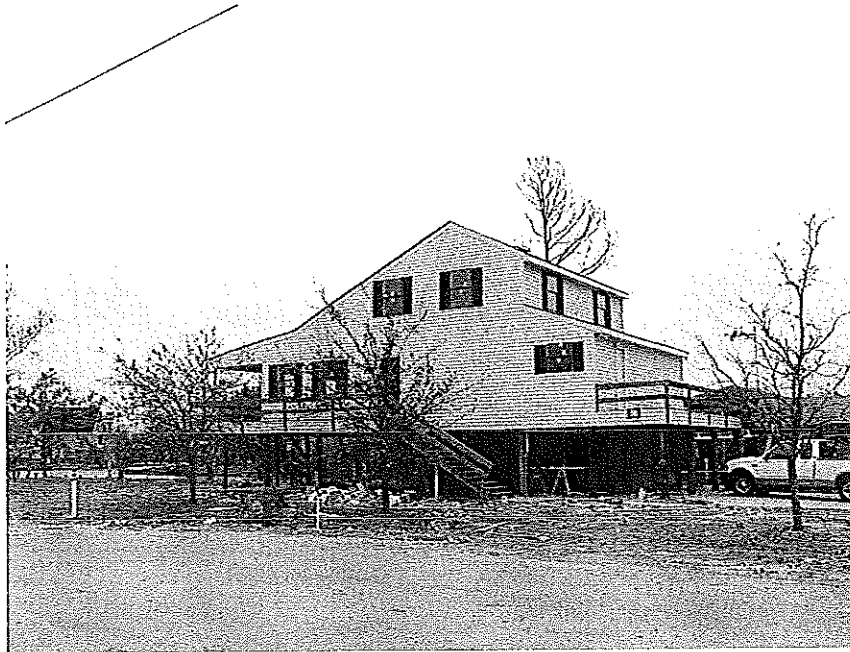
**Photo J**

Front elevation view of the elevated two (2) story single family residence located at 36 Dolphin Circle within Hancock County, Mississippi. The front elevation faces in a southwesterly direction. The exterior finish grade was relatively flat with several small standing trees along the front elevation of the residence.

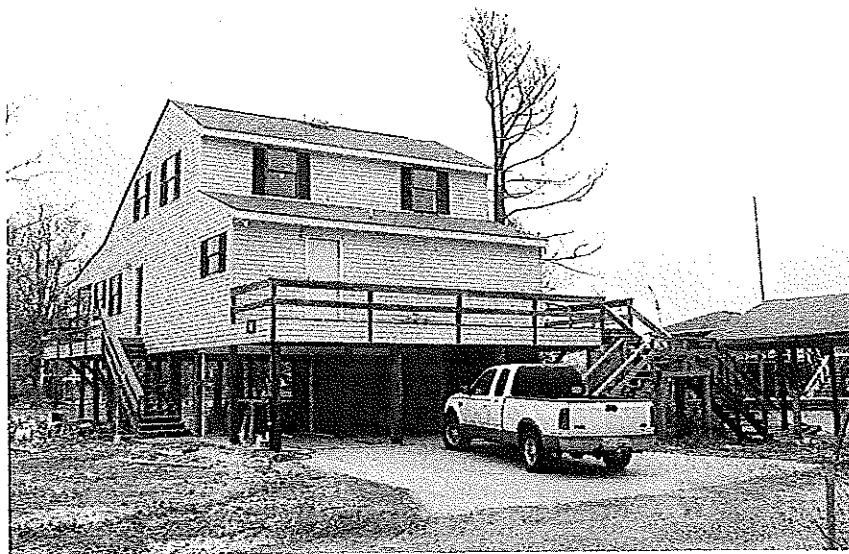
**Photo K**

Right elevation view of the elevated two (2) story single family residence located at 36 Dolphin Circle. The right elevation faces in a southeasterly direction. The exterior finish grade was flat and without trees. We noted that the roof of the residence or the roof of the adjacent boat house did not appear to have missing shingles, damaged, or loose soffits or fascia. We noted a timber deck with stairs leading to the driveway and to a boat house.

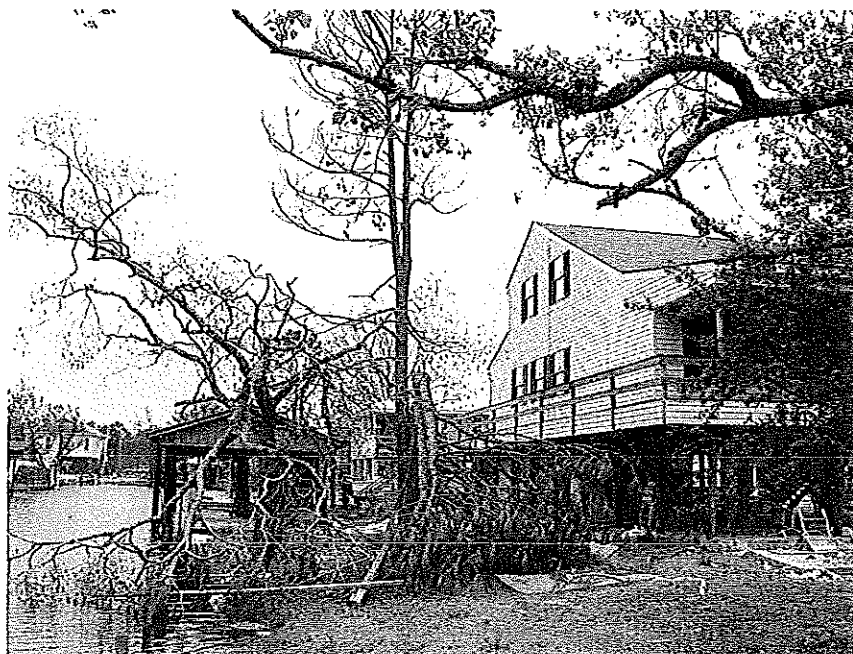
**Photo L**

Rear elevation view of the elevated two (2) story single family residence located at 36 Dolphin Circle. The rear elevation faces in a northeasterly direction. We noted that the rear elevation faced a canal. We noted an intact boat house along the edge of the canal. The exterior finish grade was generally flat and partially submerged by the existing tide adjacent to the canal. We noted standing trees and trees snapped in half. Closer review revealed that the snapped portion of the trees was above the elevation of the adjacent boat house roof.

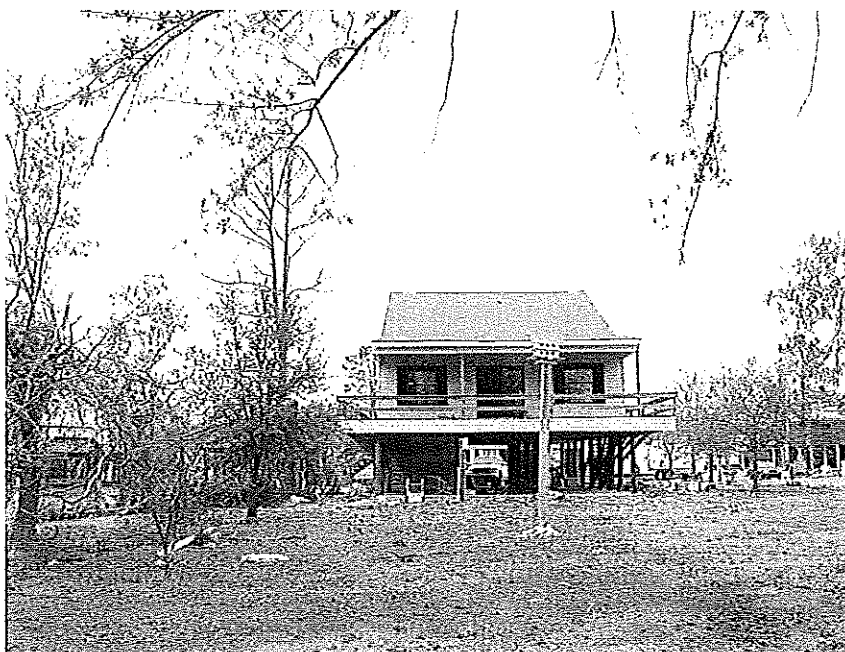
**Photo M**

Left elevation view of the elevated two (2) story single family residence located at 36 Dolphin Circle. The left elevation faces in a northwesterly direction. The left elevation also faced a canal. The exterior finish grade was generally flat. We noted standing trees along the front and rear elevation of the residence.

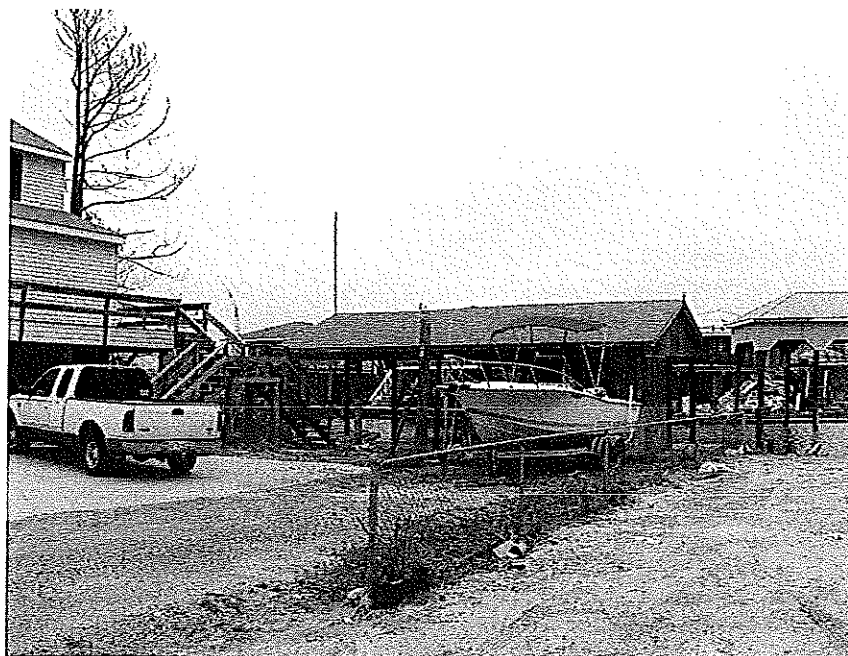
**Photo N**

View of the front elevation of the detached boat house adjacent to the residence located at 36 Dolphin Circle. We noted the roof finish and structure to be intact without visible evidence of distress.

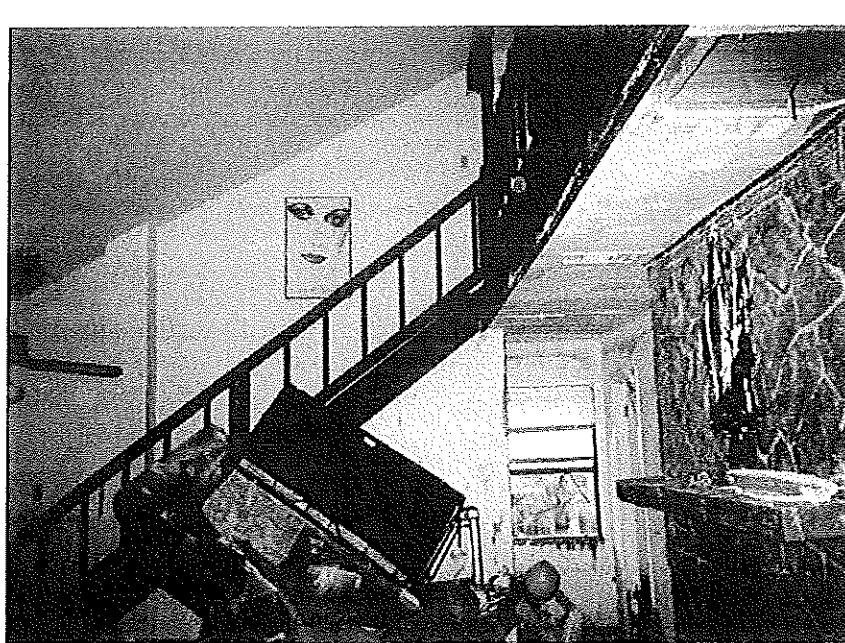
**Photo O**

Interior view of the rear elevation staircase within the first floor family room of the residence located at 36 Dolphin Circle leading to the second floor balcony taken by the insured following the storm. We noted the storm tide high water mark at the top of the stairs just below the painting.

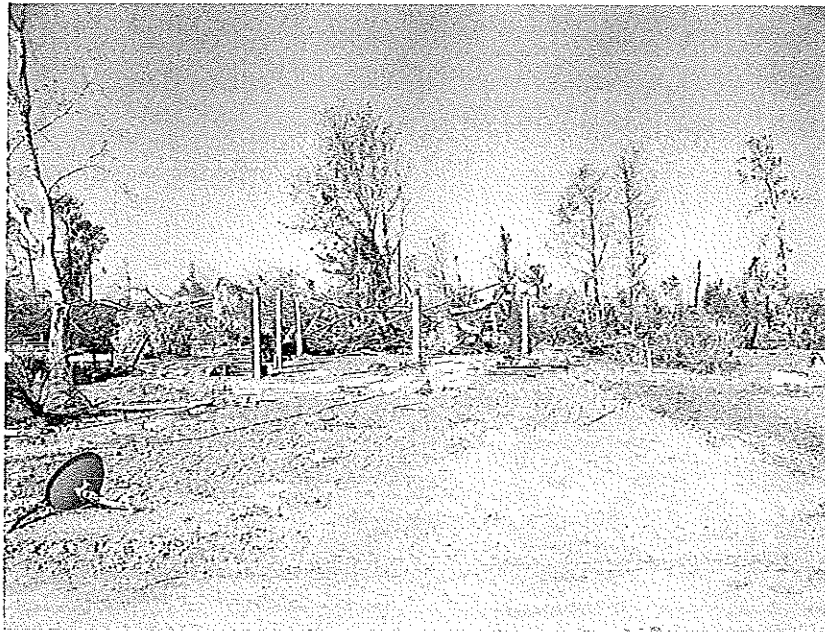
**Photo P**

Front elevation view of the former elevated single family residence located at 124 Edith Drive within Hancock County, Mississippi. The front elevation faced in a southerly direction. We noted the presence of 8" x 8" square timber piles in a 3 wide by 6 deep pattern with the two (2) rearmost comprising a double pile post. Closer review revealed that the piles extended approximately 7'-4" above the finish slab of the driveway. We further noted a small intact deciduous tree at the left corner of the front elevation of the property.

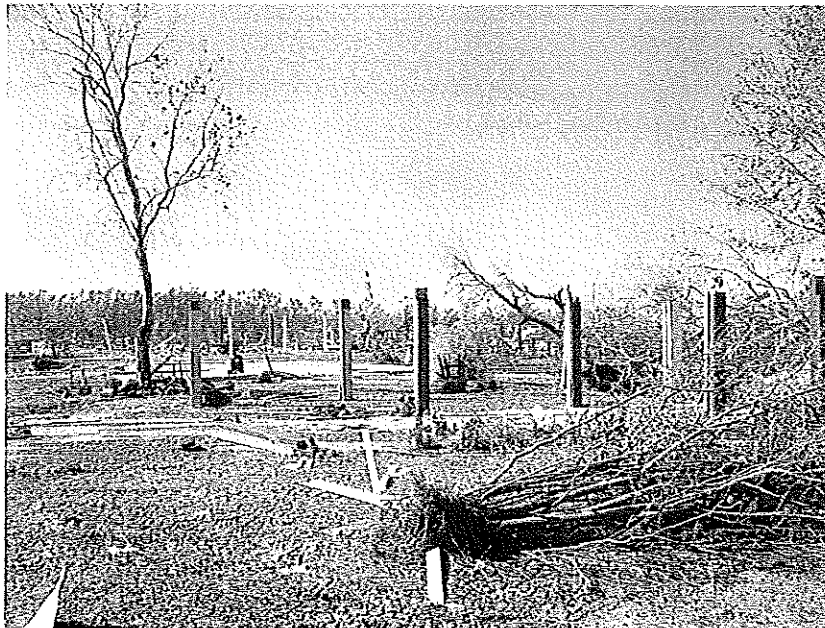
**Photo Q**

Right elevation view of the former elevated single family residence located at 124 Edith Drive. The right elevation faced in an easterly direction. We noted that the majority of the timber piles were intact, with the exception of the five (5) in the front right corner of the residence. We further noted that the neighborhood beyond the property line on the left elevation of the residence was lacking in trees and other vegetation. Closer review of the adjacent residences revealed that those residences had also been dislodged from their foundations and destroyed.

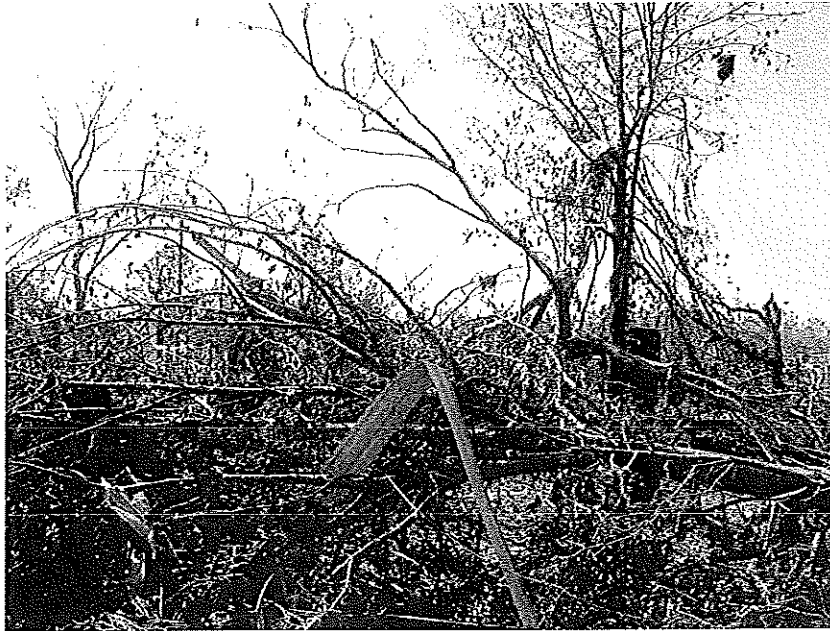
**Photo R**

View towards the rear elevation of the former elevated single family residence located at 124 Edith Drive. The rear elevation faced in a northerly direction. We noted that the brush and small trees along the rear elevation had uprooted along the canal bank. We also noted that water borne debris was evident in the trees beyond the front elevation of the residence at a height of approximately 15'-0" above the exterior grade.

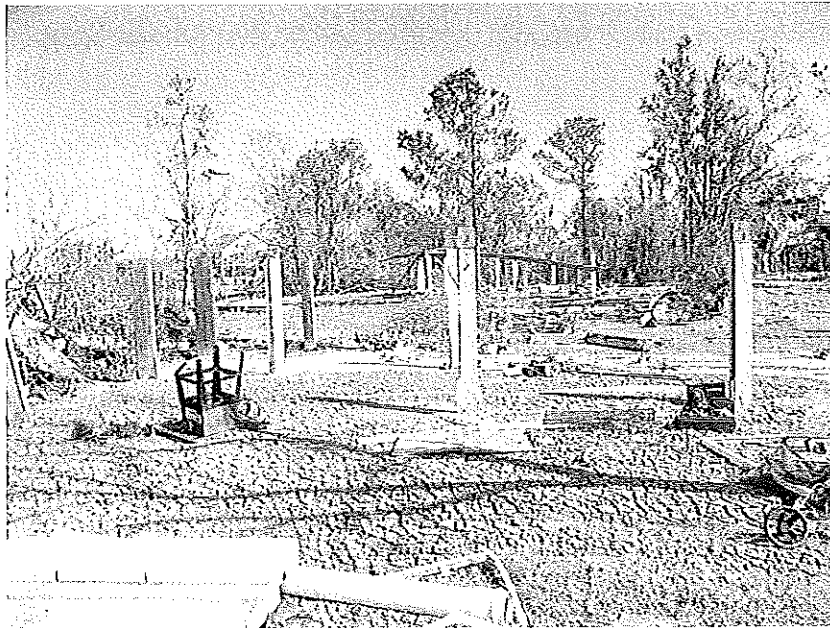
**Photo S**

Left elevation view of the former elevated single family residence located at 124 Edith Drive. The left elevation faced in a westerly direction. Closer review of the adjacent residences revealed they had been dislodged from their foundations and destroyed. However, we noted two (2) residences in the tree line beyond the canal which were heavily damaged but remained intact on their foundations.

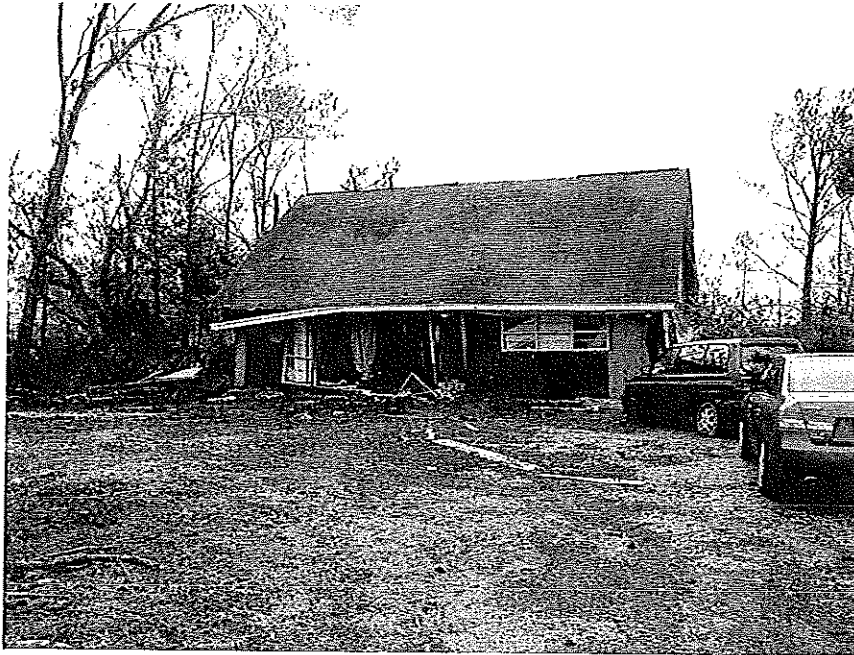
**Photo T**

Front elevation view of the one and a half (1 1/2) story single family residence located at 3037 Washington Street within Hancock County, Mississippi. The front elevation faces in a northerly direction. The exterior finish grade sloped away from the residence at the perimeter but otherwise was relatively flat with no trees. The surface of the ground was covered in a thick gray mud up to 1/2" thick. We noted that the timber framed residence was constructed over a cast-in-place concrete slab on grade. We also noted that the exterior wall finishes and some windows were missing. The fascia and soffit were damaged and loose. The front elevation roof slope sustained minimum damage to the lower left corner.

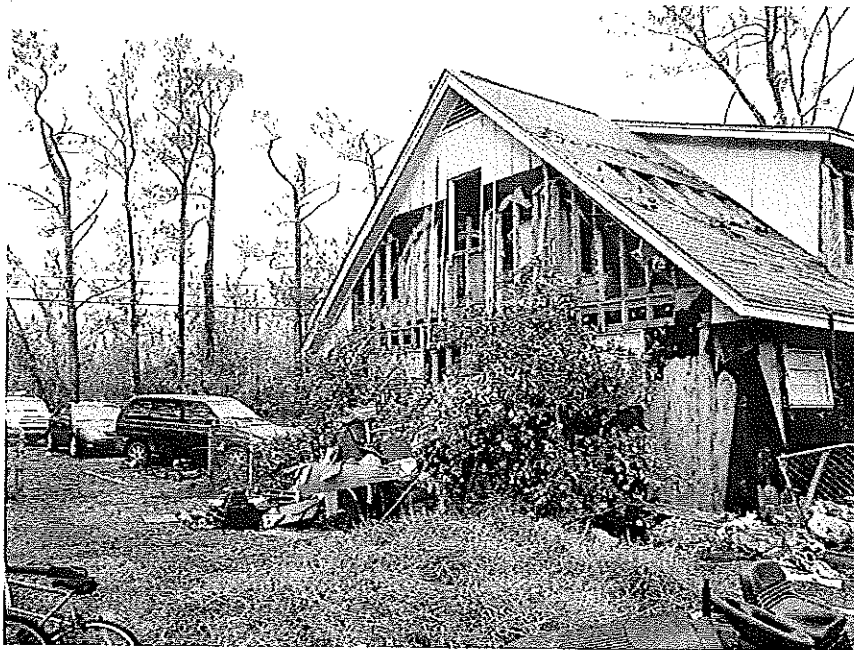
**Photo U**

Right elevation view of the single family residence located at 3037 Washington Street. The right elevation faces in a northwesterly direction. The exterior finish grade along the right elevation sloped away from the residence at the perimeter but otherwise was generally flat. The exterior wall finishes and some of the wall sheathing on the residence were missing, exposing the timber framing on both floors. The height of the missing wall sheathing corresponded to the location of missing plywood roof sheathing on the rear elevation roof slope.

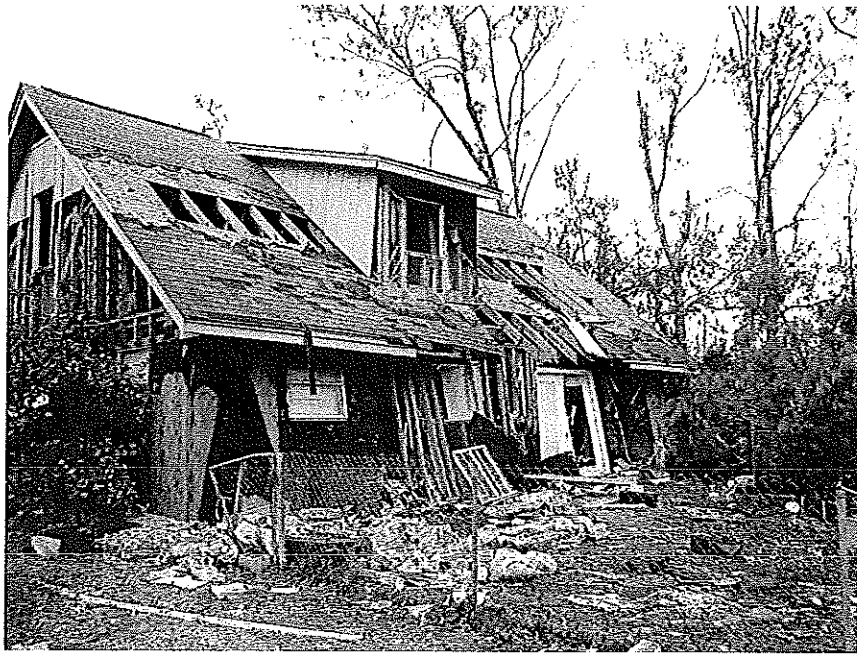
**Photo V**

Rear elevation view of the single family residence located at 3037 Washington Street. The rear elevation faces in a southwesterly direction. The exterior finish grade sloped away from the residence at the perimeter but otherwise was relatively flat with no trees. The exterior wall finishes on the residence were missing and a significant portion of the timber framing was exposed. Further, we noted that the center of the wall was leaning inward at the top of the wall. The roof was missing a significant amount of roof sheathing as well as shingles along the center section and above the leaning wall. We also noted that the fencing along the right, left, and rear property lines was bent.

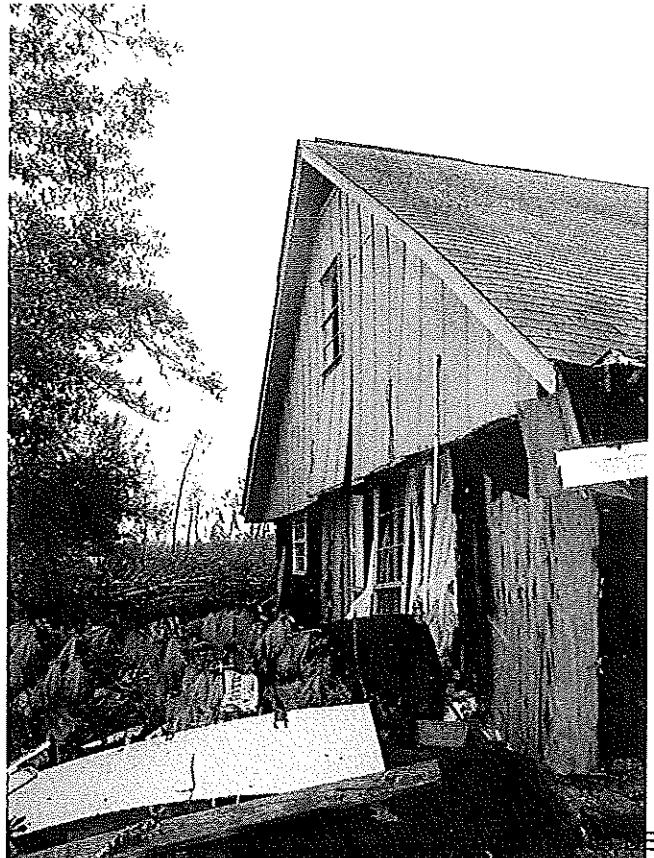
Left elevation view of the single family residence located at 3037 Washington Street. The left elevation faces in a southeasterly direction. The exterior finish grade sloped away from the residence at the perimeter but otherwise was generally flat and littered with debris. The first floor exterior wall finish on the residence was missing and the gable end wall sheathing was loose.

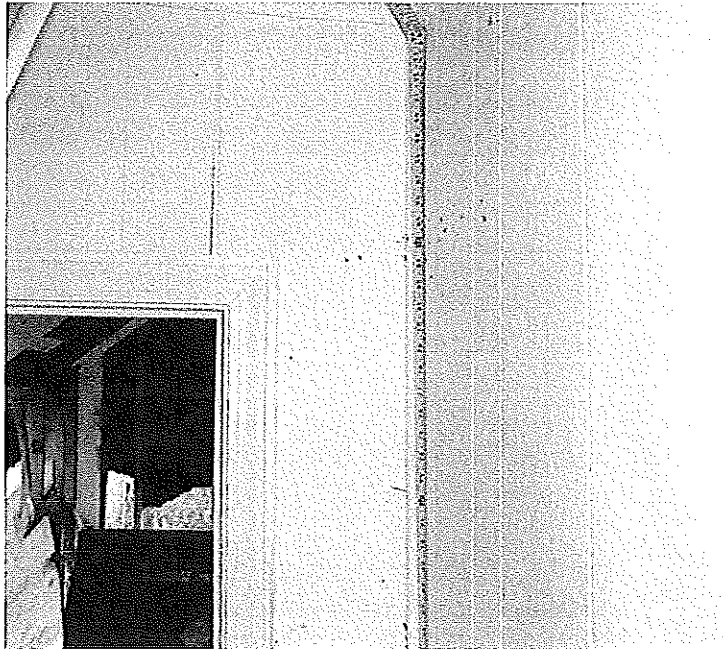
**Photo X**

Interior view of the right interior wall of the upstairs landing at the center of the residence located at 3037 Washington Street. We noted the high water mark to be approximately 7'-0" from the finished surface of the upper floor elevation. Further, we noted damaged ceilings and interior wall finishes in the rooms of the upper floor.

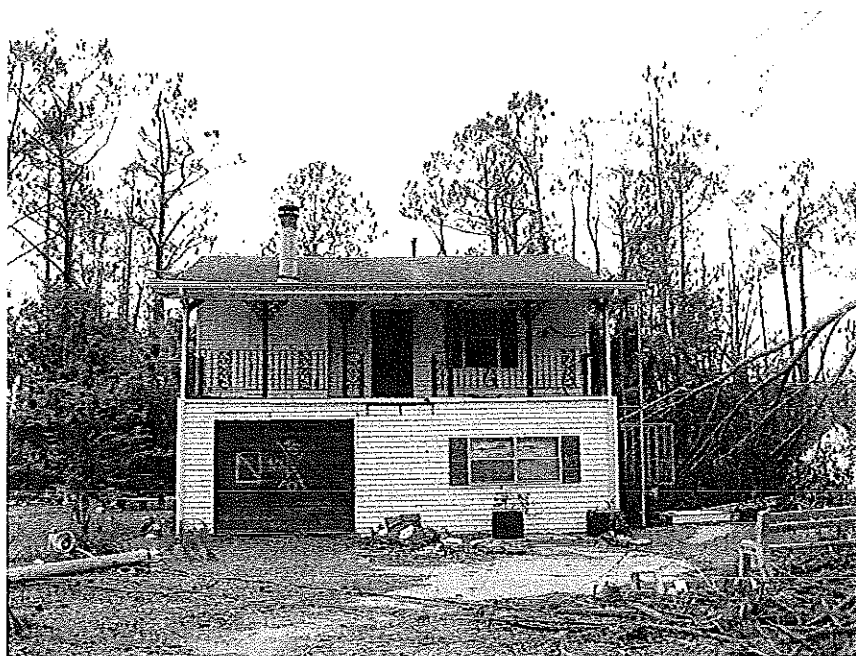
**Photo Y**

Front elevation view of the elevated one (1) story single family residence located at 22 Wolfe Street within Hancock County, Mississippi. The front elevation faces in an easterly direction. We noted that the stairway leading up to the elevated front porch was missing. We also noted that the front door was missing. We further noted minor damage to the gutter along the front elevation roof eave. The majority of the trees behind the residence remained standing, with only minor limb damage.

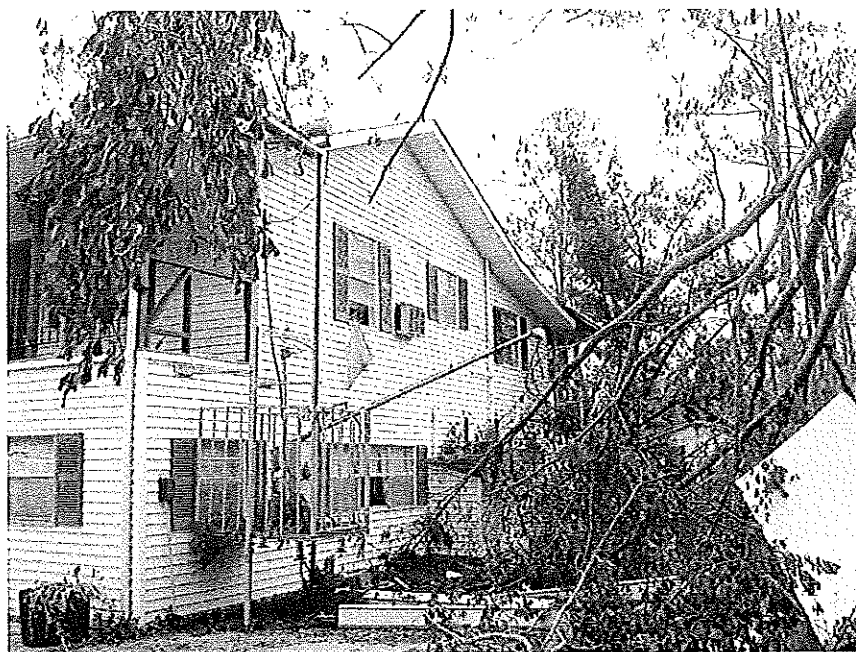
**Photo Z**

Right elevation view of the single family residence located at 22 Wolfe Street. The right elevation faces in a northerly direction. We noted that the screen in the frontmost window on the elevated first floor was hanging from the window sill. We also noted that the conduit from the power meter to the roof, which contained the power lines and was located along the exterior wall adjacent to the external elevator, had been detached from the residence. Further, we noted a fallen tree adjacent to the right elevation and a pile of debris beneath the branches.

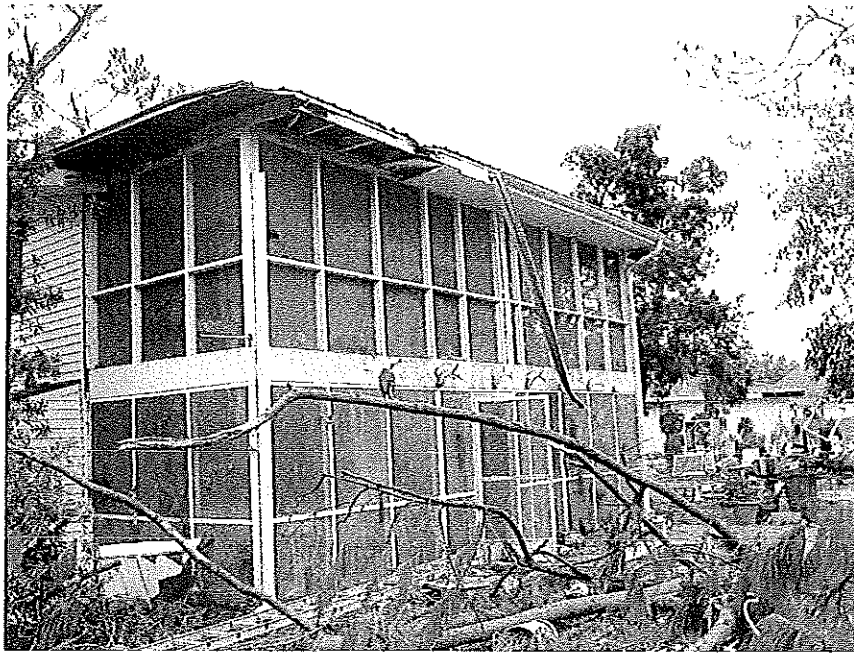
**Photo AA**

Rear elevation view of the single family residence located at 22 Wolfe Street. The rear elevation faces in a westerly direction. We noted damage to the roof overhang framing, soffits, and metal roofing along the right and rear elevation roof eaves at the right corner of the screened porch. We also noted that the gutter along the right half of the rear elevation roof eave had been damaged as well as the downspout at the right corner. Fallen tree limbs and other debris were spread across the backyard of the residence.

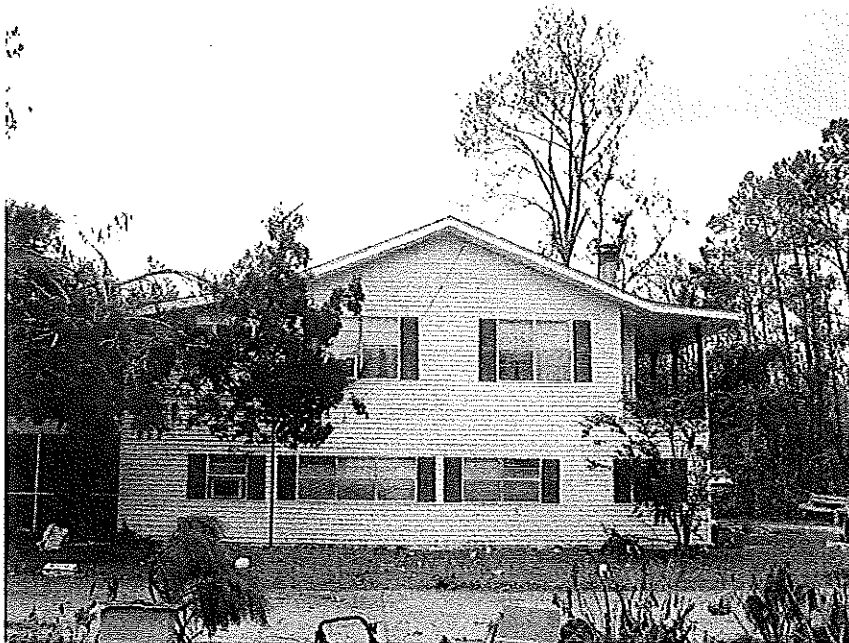
**Photo BB**

Left elevation view of the single family residence located at 22 Wolfe Street. The left elevation faces in a southerly direction. We noted several broken windows on the ground floor of the left elevation. We also noted that the tree near the rear corner of the residence remained standing, but had damaged limbs.

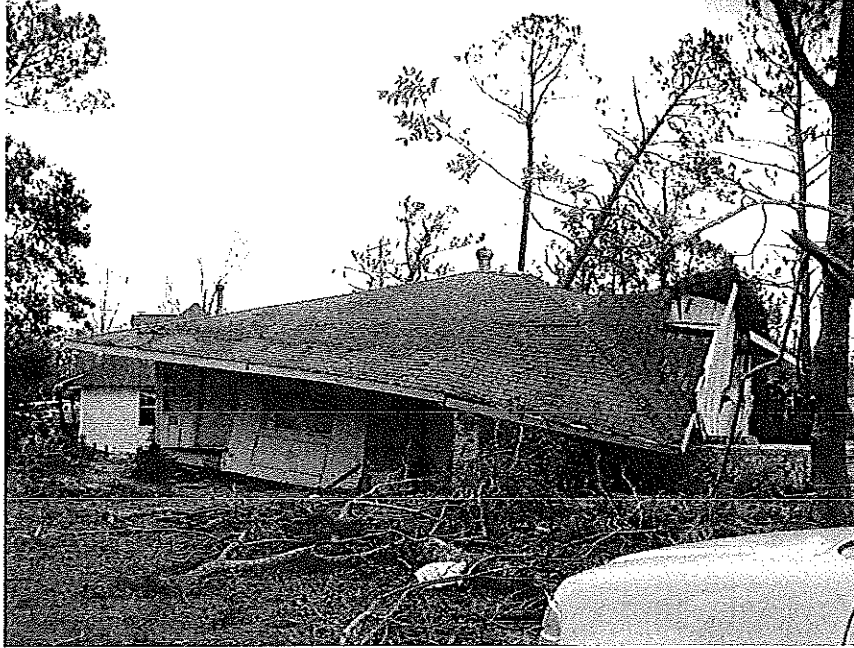
**Photo CC**

View looking south towards the neighboring property from the left elevation of the residence located at 22 Wolfe Street. We noted that the neighboring former residence had been moved off its foundation. We also noted that the remaining roof structure had the majority of its shingles still attached.
