Expert Report of John A. Fowler, P.E.

SPECIAL INSPECTION

Mucha Residence
2555 South Shore Drive
Biloxi, Mississippi 39532

Project No. P2557

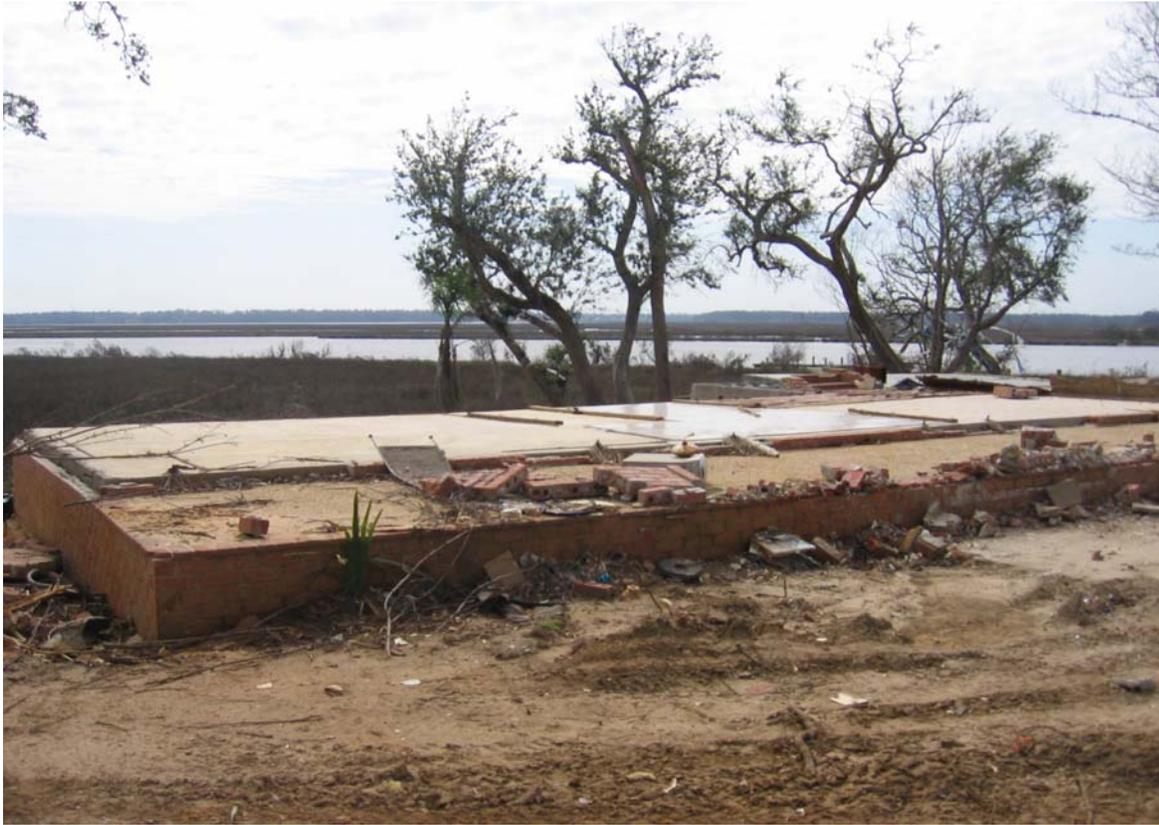
There was little left of what had been this house during our inspection. Only parts of the foundation, some 2 x 6 wood sills, and a few pieces of OSB exterior sheathing remained. Some brick veneer was present as well.

Photo 1: Site conditions on February 22, 2006

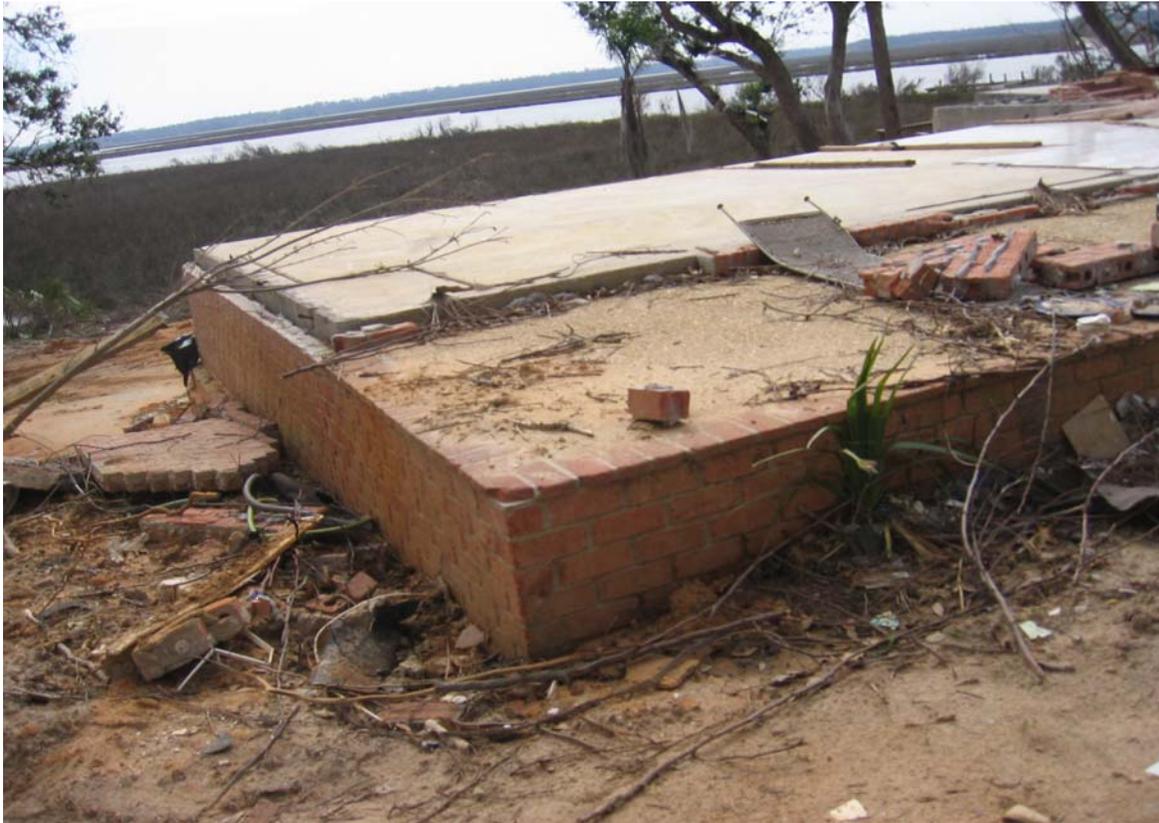
The rest of the foundation is in fair condition, and it may be possible that it can be reused. The block foundation walls are filled with reinforced concrete. This is probably why they have survived.

Photo 2: Close up of what's left of the parts of the foundation and foundation wall

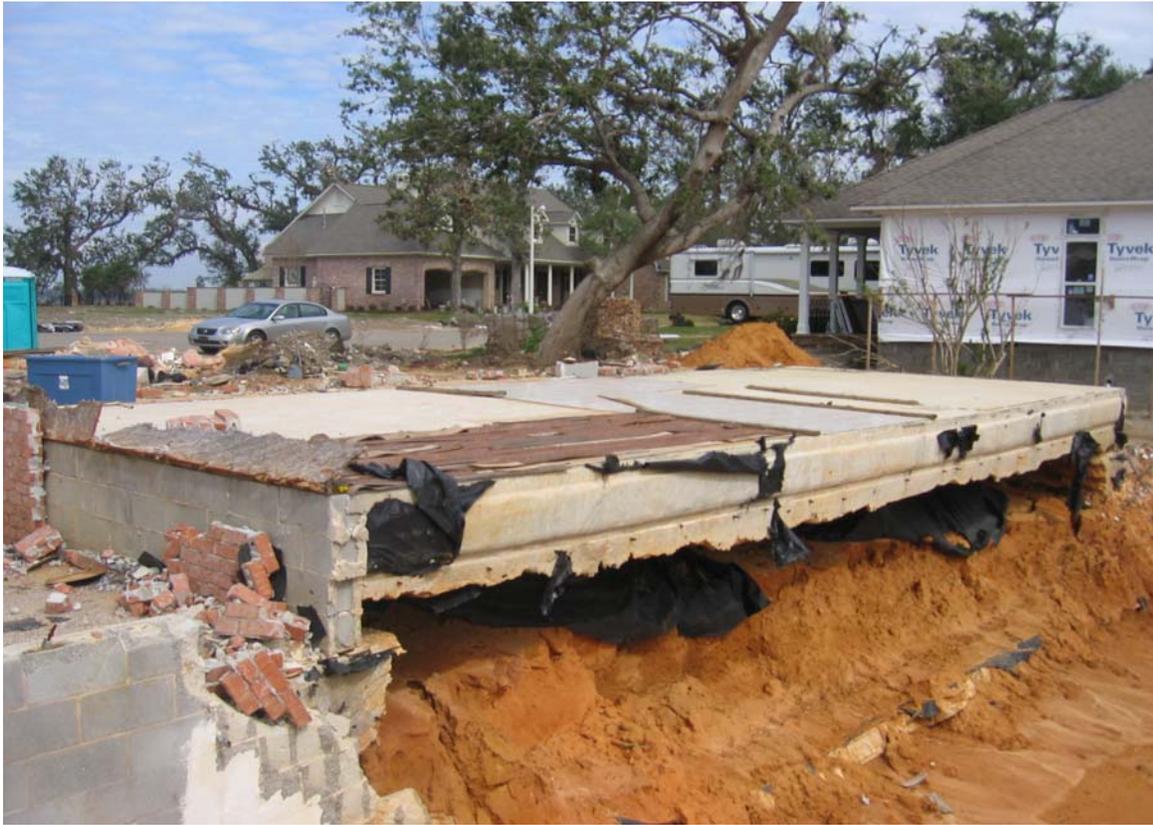
Much of the fill washed out from under the slab on grade part of the house during Hurricane Katrina, causing this slab to settle severely. This part of the slab is in poor condition.

Photo 3: View from the rear showing settled slab and washed out fill

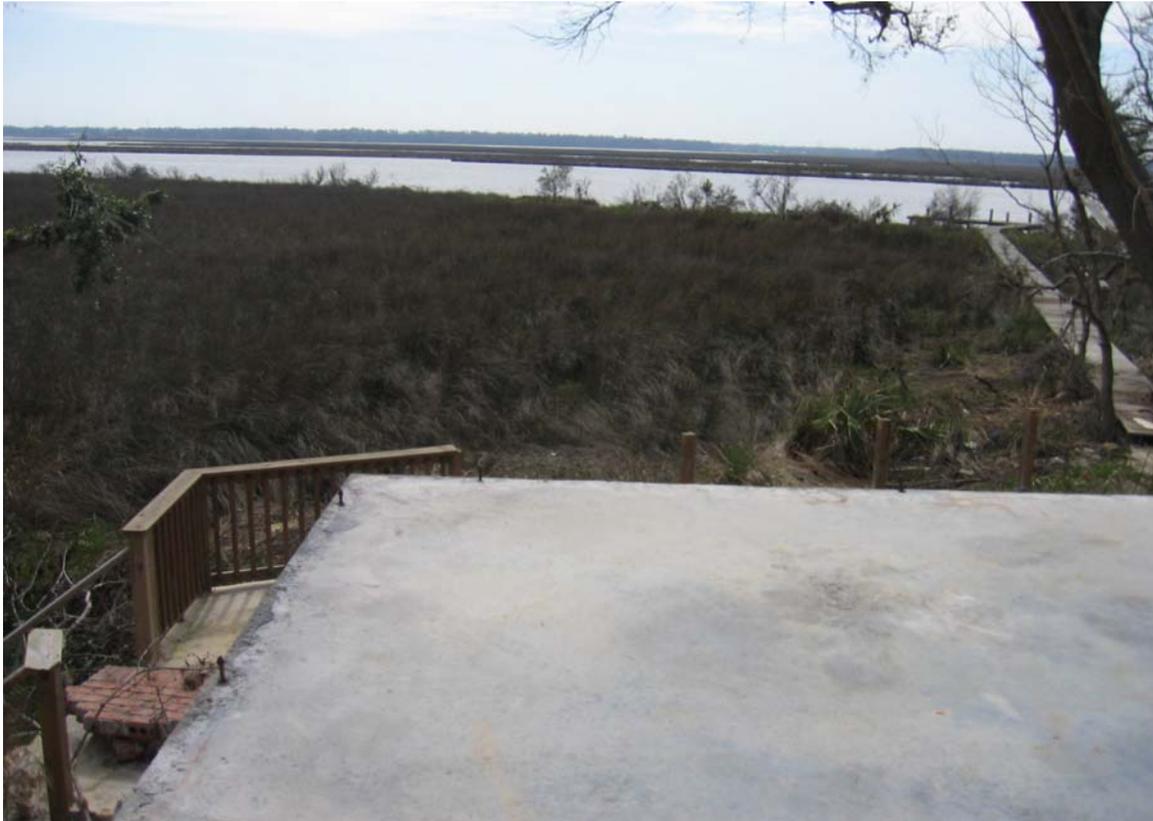
Due to storm surge damage causing the structural fill to wash out from beneath the floor slab on the lowest level, this slab has settled downward and is in poor condition.

Photo 4: Sagged and settled slab with no fill beneath

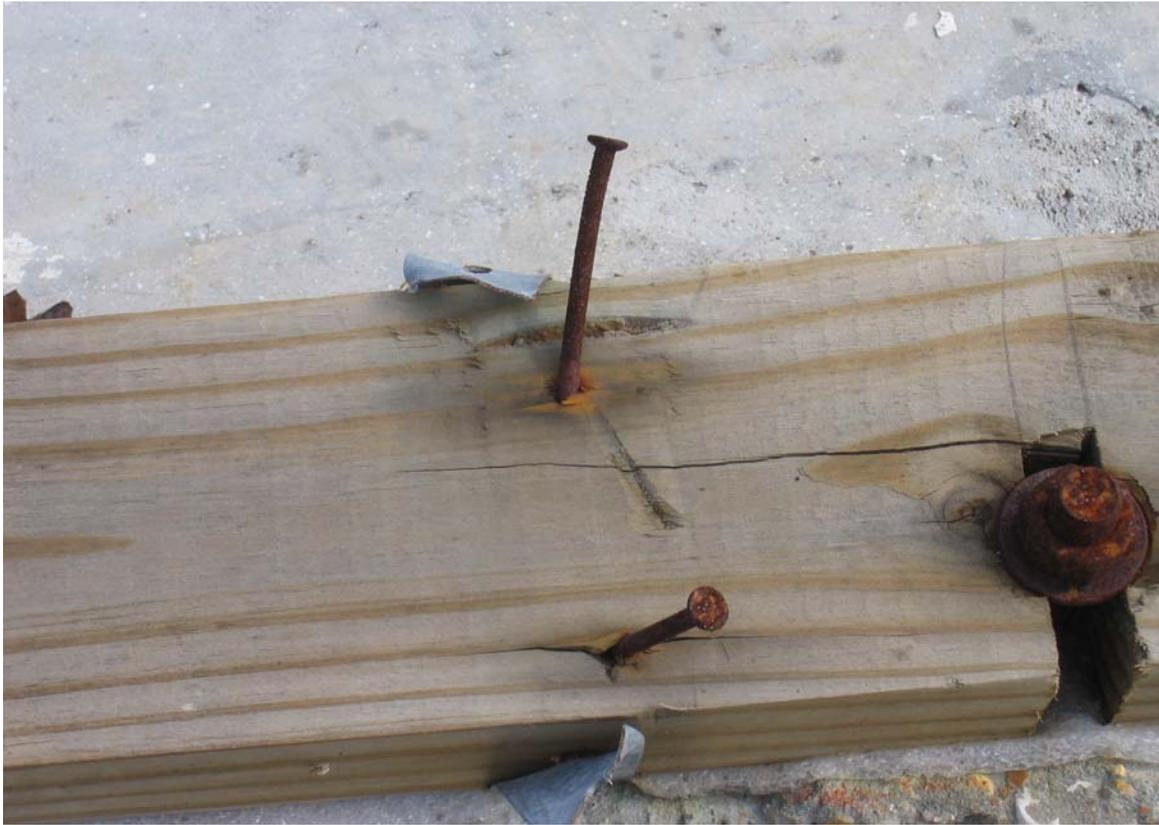
The construction of the wood framing for the garage was different than the house. In the garage, studs were toenailed in place with 10d nails, and there were no straps. This made the garage more susceptible to damage from the high winds of Hurricane Katrina.

Photo 5: Toenailed studs evident in what remains of the sill

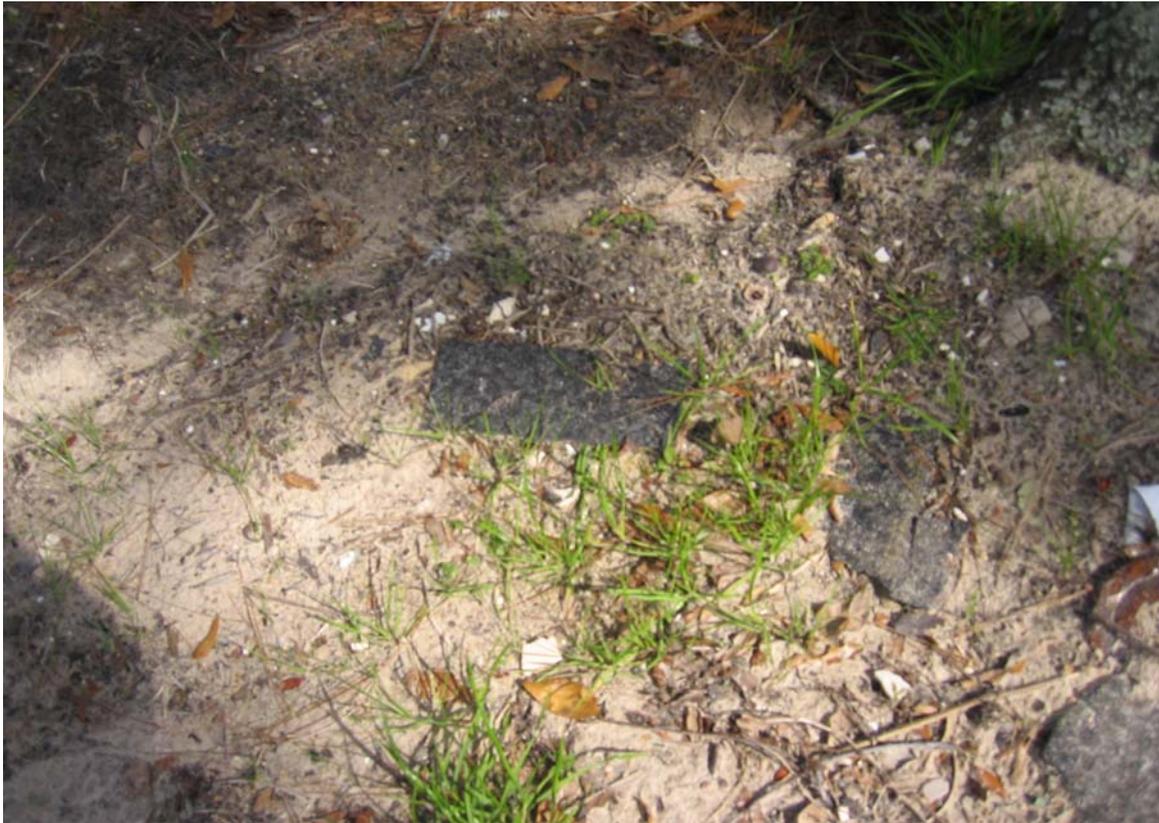
- Homeowner's eyewitness report about garage being blown apart before 9:00 AM and before the arrival of the storm surge on the property
- Many shingles were found approximately 150 to 200 feet to the northwest of the house where they were blown off the Mucha house during Hurricane Katrina. These shingles cannot float, and could only have gotten to this remote location by being blown there as they were blown off the roof of the Mucha's house. Shingles of this type will peel off a house at approximately 95 mph and higher winds. The fact that they were all found 150 to 200 feet to the northwest indicates that they blew off the Mucha's house during high winds, and before the house collapsed.

Photo 6: Shingles found 150 to 200 feet to the northwest of the house

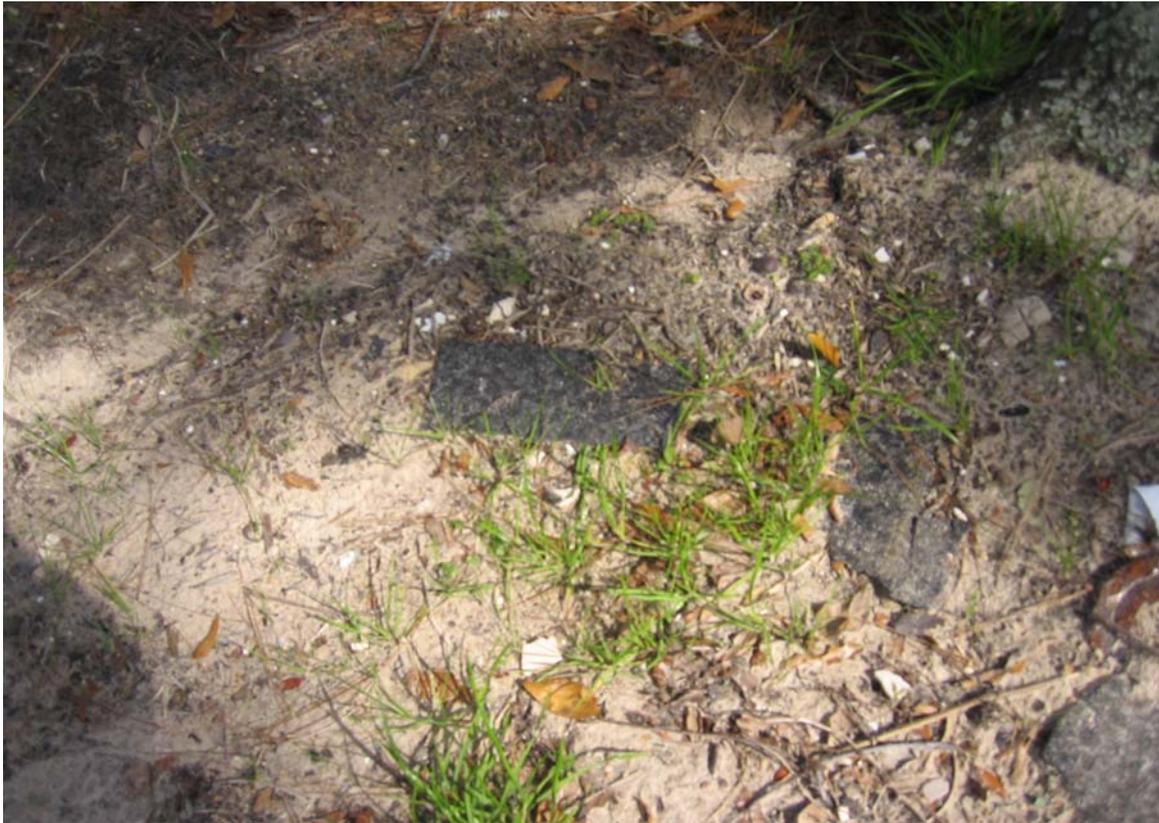
Photo 8: Shingles found to northwest
