Reference: Katrina Litigation
Mr. and Mrs. Thomas and Pamela McIntosh
2558 South Shore Drive
Biloxi, MS 39532

Expert Witness Report

STRUCTURAL RESPONSE OF THE PROPERTY OF MR. AND MRS. THOMAS McINTOSH DURING HURRICANE KATRINA (8/29/02)

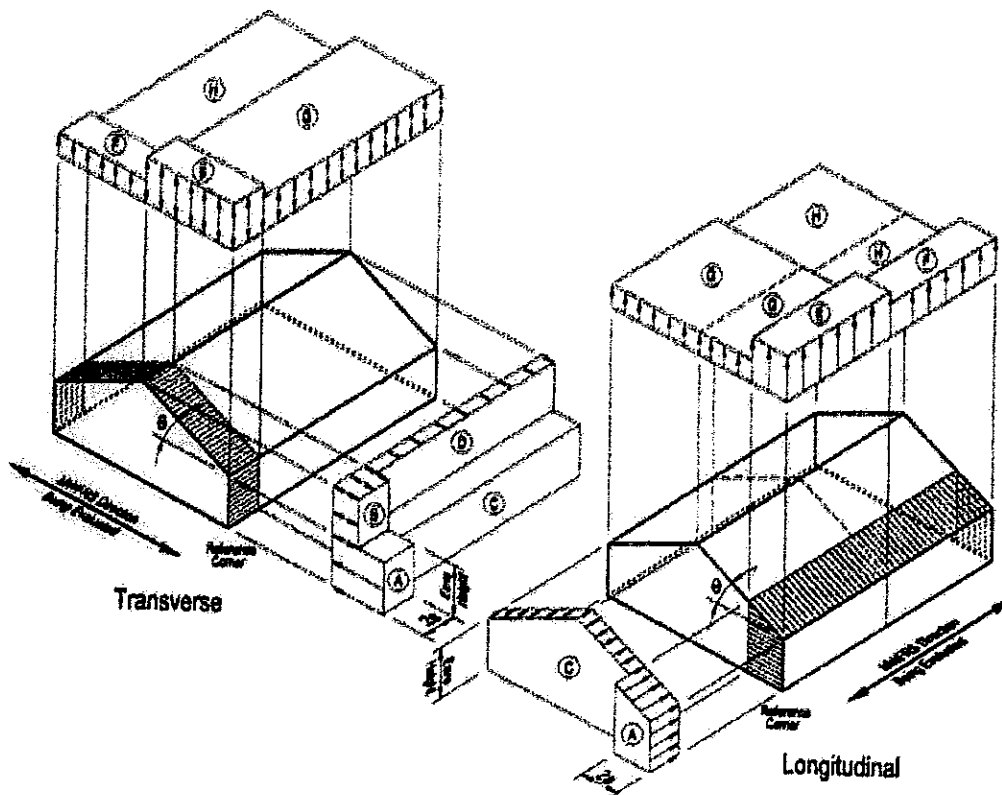
Figure 1. Direct inward, outward suction, and uplift pressures in the direction of high velocity wind on the McIntosh Residence

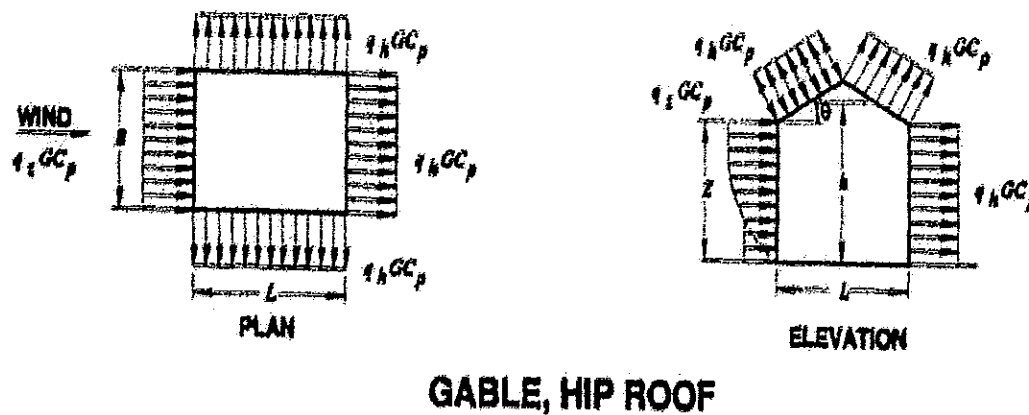
Figure 2. Main wind force resisting system (MWFRS) external and internal pressures as per ASCE-7

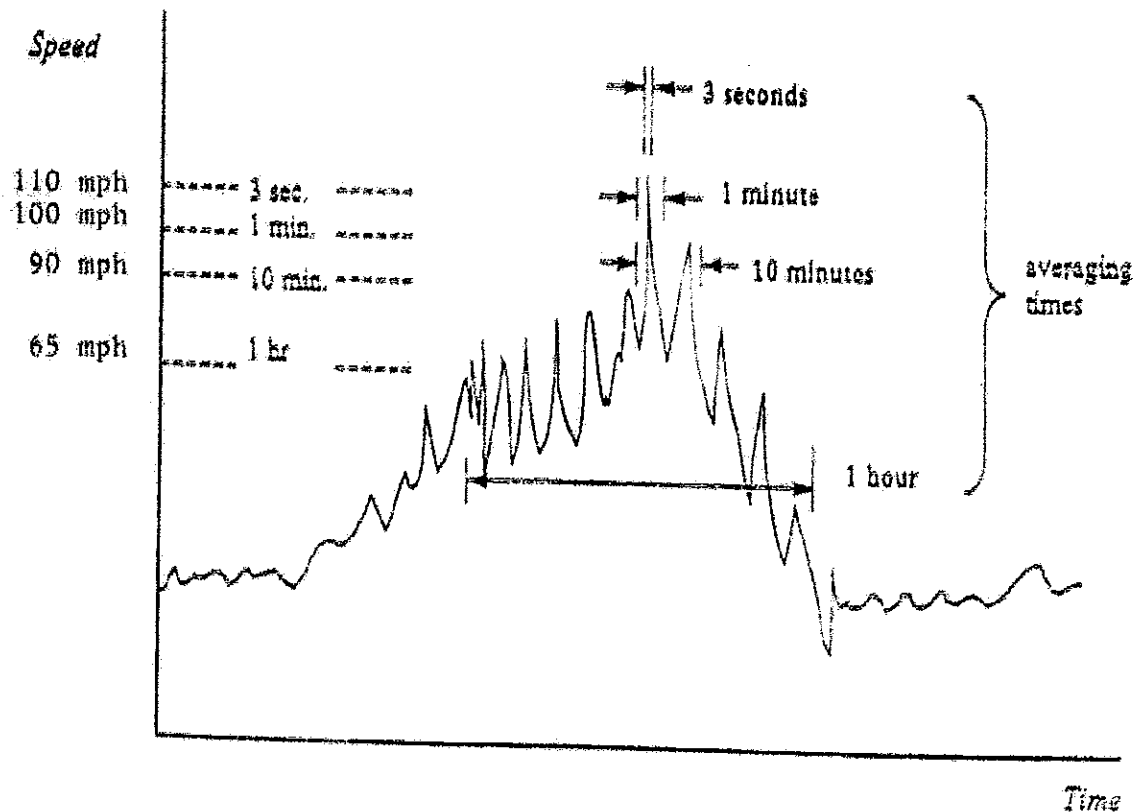
Figure 12. Typical wind speed variation vs. time from Ref. 6, see true measured hurricane wind loading in
Figure 13 and in the Appendix.

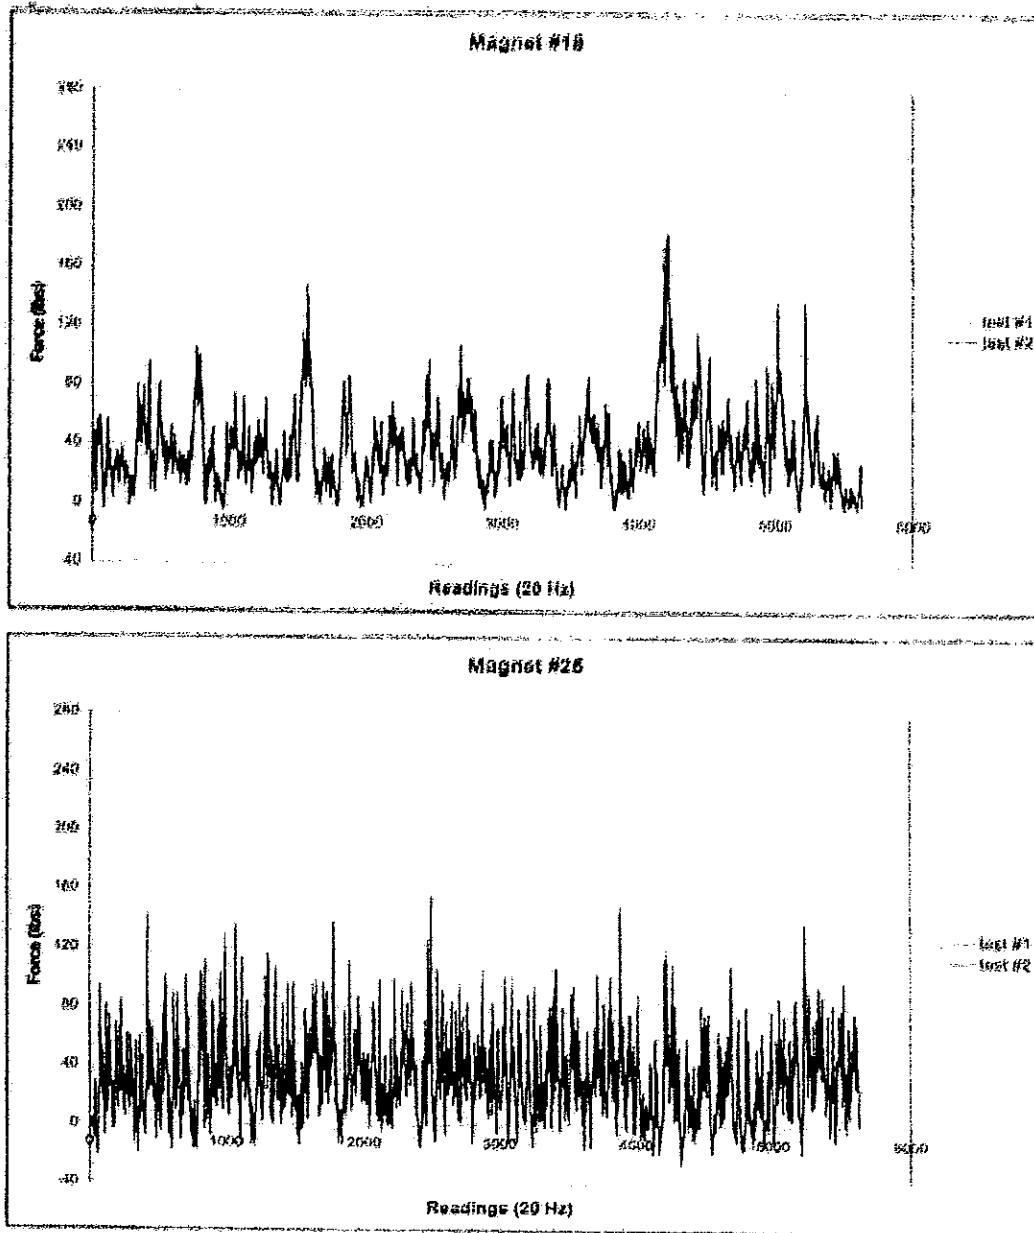
Figure 13. Instantaneous uplift wind pressure vs. time in seconds for Hurricane Andrew (Florida, 1992)
(#18 and #25 are two one square foot areas on a roof 6 feet apart)

The data in Figure 13 was collected and plotted at the rate of 20 (Hz), readings per second, of real life. The instantaneous peak uplift pressure on a flat roof can vary as much as 200 pounds per square foot for a sustained wind speed of 115 mph. It is important to note that the unit dead load weight of a typical wooden roof similar to that built at the McIntosh house is about 13 pounds per square foot. Accordingly; the maximum instantaneous uplift wind loading at the flat corners is about 15 times the weight of the roof.

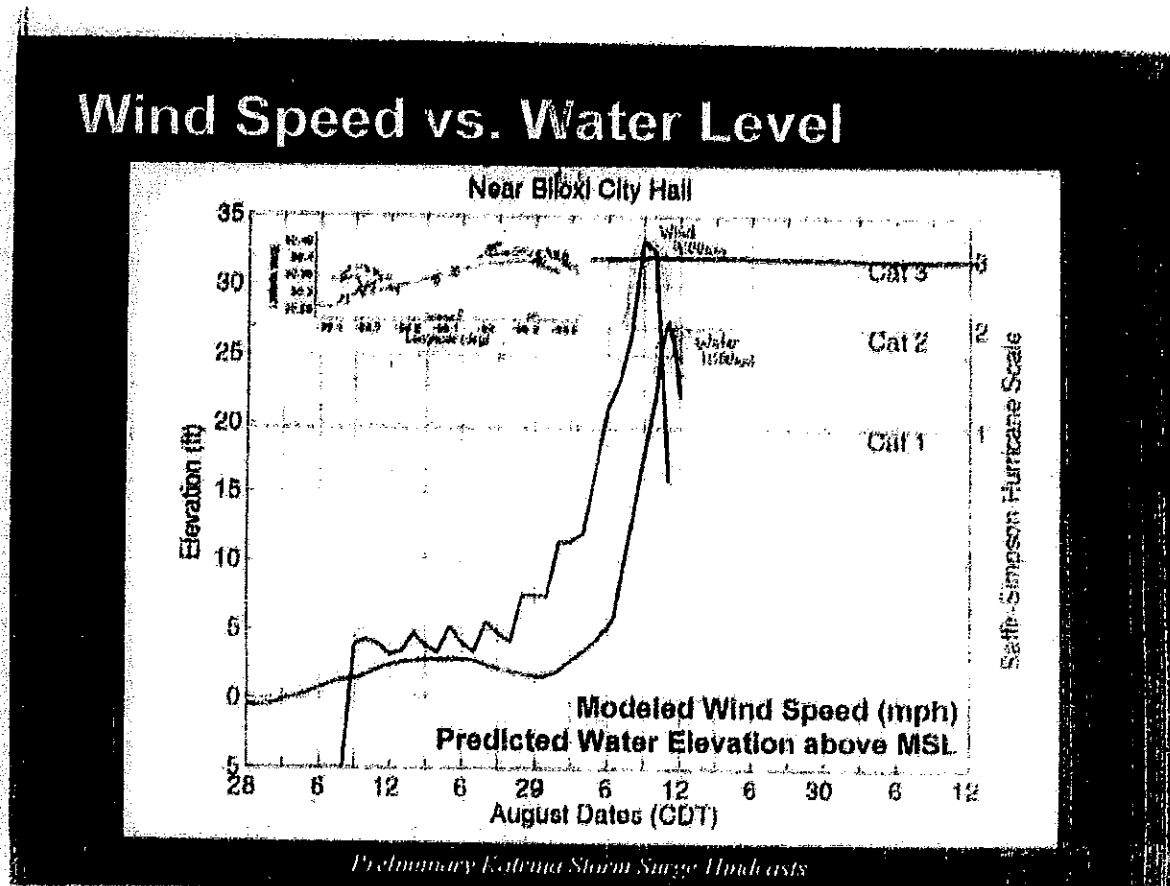
The water rise during hurricane Katrina lasted several hours and affected about 100 miles of coastline. The peak wind speed generally preceded the peak surge, as expected, and for hurricane Katrina, this lag time has been estimated by most meteorological researches and experts to vary between 2-3 hours for the McIntosh site, see Figure 15.

Figure 15. Wind speed and water surge elevation vs. time for Biloxi, MS (Reference 11)

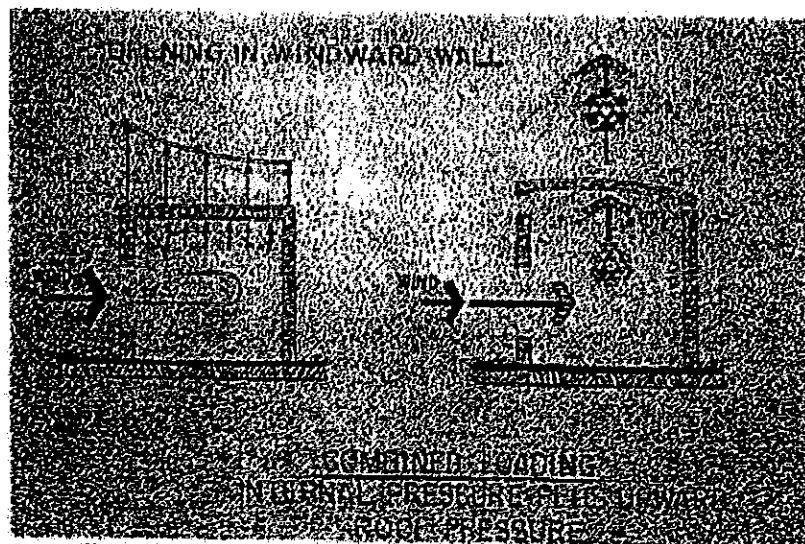
Figure 16. This figure is reproduced from the FEMA publication

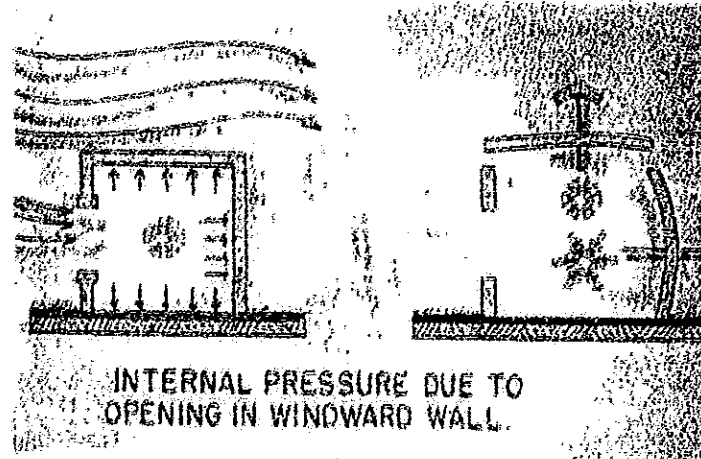
- *If windows on the windward wall were open or broken, the pressure within the building would increase and push even harder from the inside out. See Figure 4.2 (Figure 17 below).*

Figure 17. This figure is reproduced from the FEMA publication

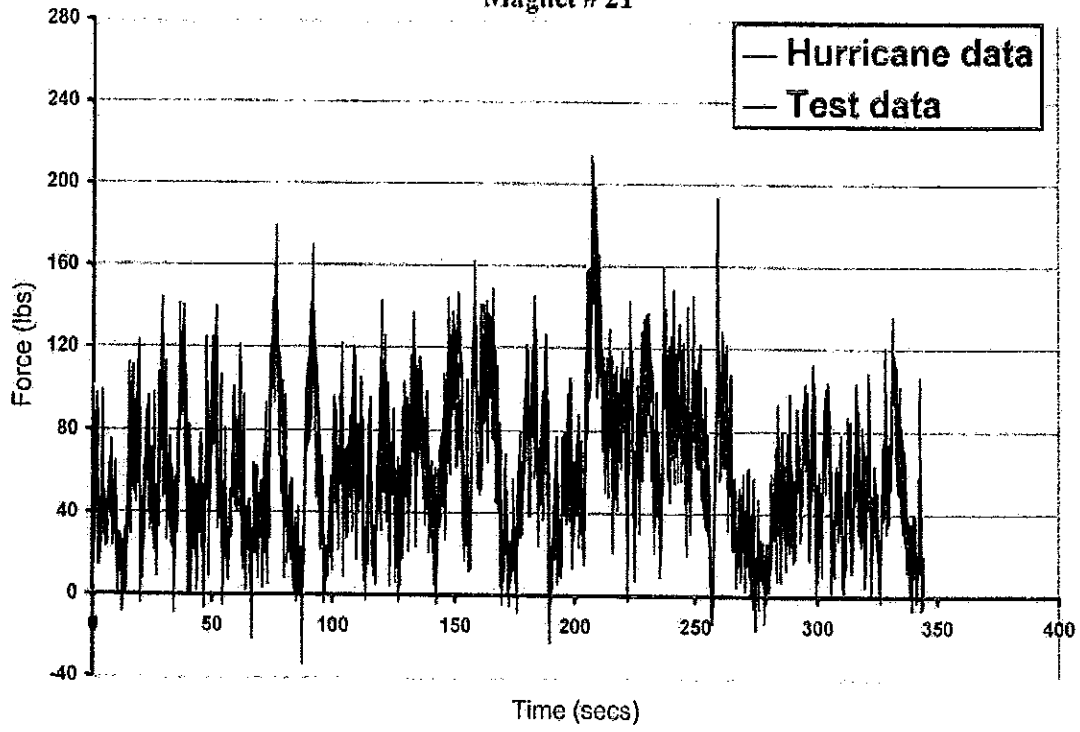
With Further Research Hazard Mitigation of Damage due to True Hurricane Wind Loading on Metal Roofs Is Now Feasible.

Trapezoidal Roof : 24" Panel - 24 gauge
Wind Speed = 110 mph
Magnet # 21
