**IN THE UNITED STATES DISTRICT COURT  
FOR THE SOUTHERN DISTRICT OF MISSISSIPPI  
SOUTHERN DIVISION**

**STATE FARM FIRE AND CASUALTY COMPANY'S  
MOTION FOR PARTIAL SUMMARY JUDGMENT**

**FITZPATRICK REPORT**

This report presents information about Katrina's wind and storm surge elements at 506 River View Road in Bay St. Louis, MS. Section 1 provides background information on the physics of the storm surge. Section 2 describes Katrina's wind field, its storm surge, and the timing of both events. Section 3 summarizes the findings.

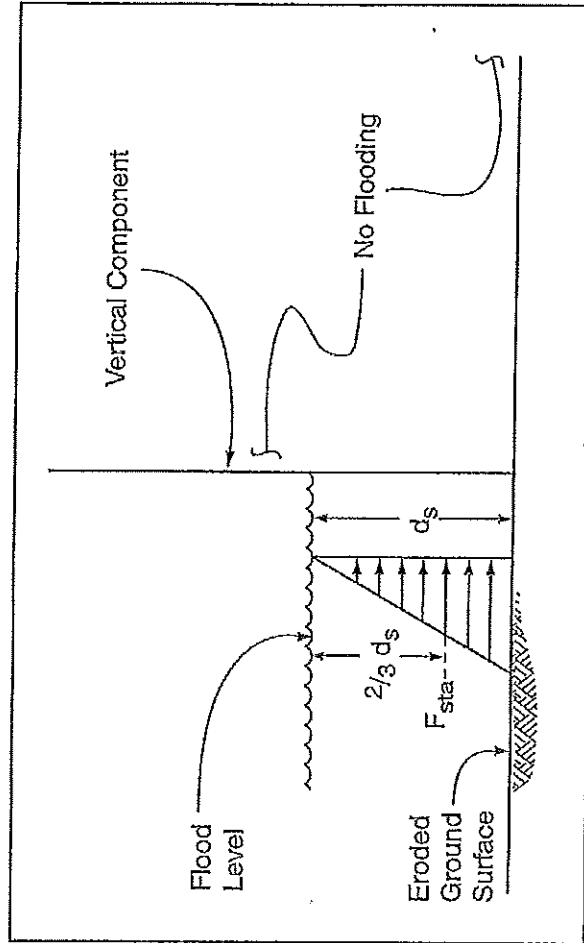
Figure 11-5

Water located on only one (1) side of a wall will result in lateral force against the wall as graphically indicated in the figure below.

If you have water on only one side, the resultant force from the hydrostatic pressure  $F_{sta}$  is:

Acting at a distance of  $\frac{2}{3}d_s$  below the surface or  $\frac{2}{3}(10) = 6'-8"$  below the water surface

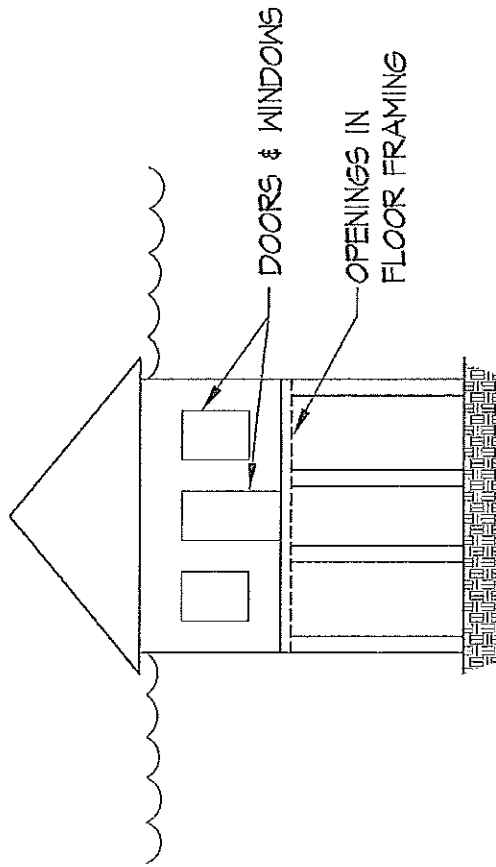
With multiple openings within which rising water can eventually enter the structure, such as openings in the elevated floor framing, doors, and windows, it is unlikely that significant differential water heights will exist between the exterior and interior of the structure over extended periods of time.

If an equal depth of water is on both sides of the wall, the hydrostatic component of the lateral water pressure is zero since the pressure on each side is the same, but acting in the opposite direction. Since the lateral water pressure is a combination of both hydrostatic and hydrodynamic forces, the lateral water pressure is not necessarily equal to zero when the hydrostatic component is zero.

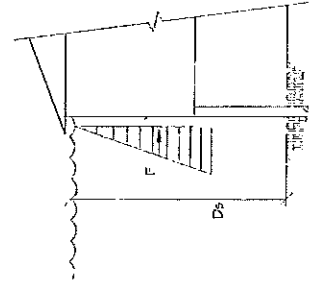
Hydrostatic Component  $F_{sta} = 0$  Assuming water rose slowly enough to allow somewhat equal heights on interior and exterior of wall

In hurricane surge, broken wave flow is more accurate, which is accounted for in the Velocity component

Lateral Water Pressure = Hydrostatic + Hydrodynamic

$$= 0 + 3,314 \text{ PLF}$$

$$F_{lat} = 3,314 \text{ PLF}$$

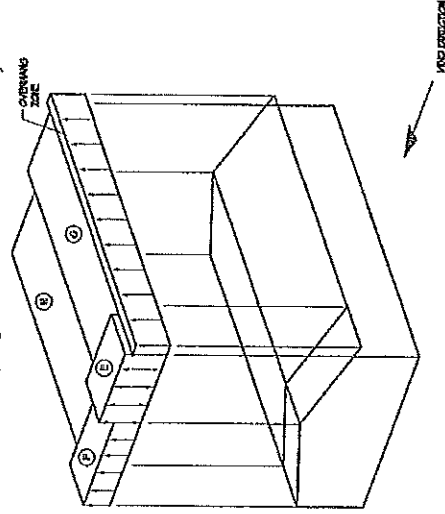
| Roof Location | Zone | GCp |
|---|---|---|
| Interior Leeward | H | -0.43 |
| Overhang | | -0.68 |

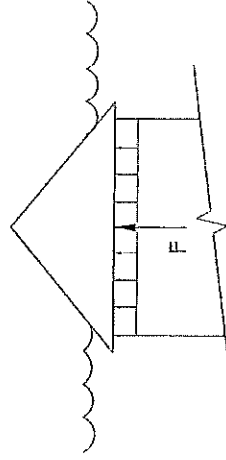
Water Buoyancy Force on Residence:

39,950 PLF
